APPENDIX D-DEFINITION OF TERMS ASSOCIATED WITH STRUCTURAL CRITERIA EVALUATION AND SITE PHOTOGRAPHS

4.0 YARD AND PERIMETER WALL - REFERENCE PHOTOS

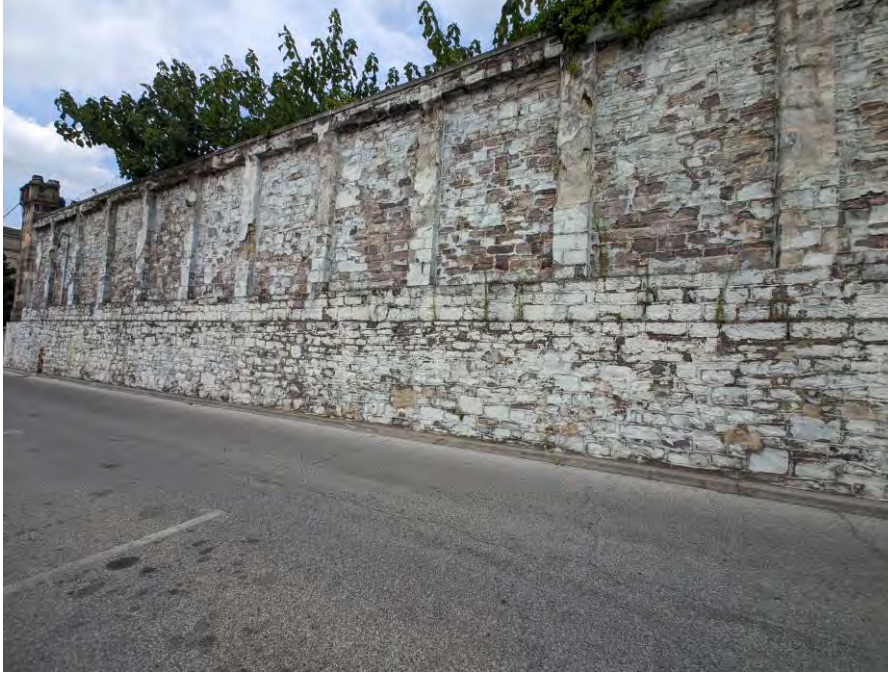
Photo 1

Location: East wall southern end

Description: Wall in *poor* condition, deteriorated stone and loose debris

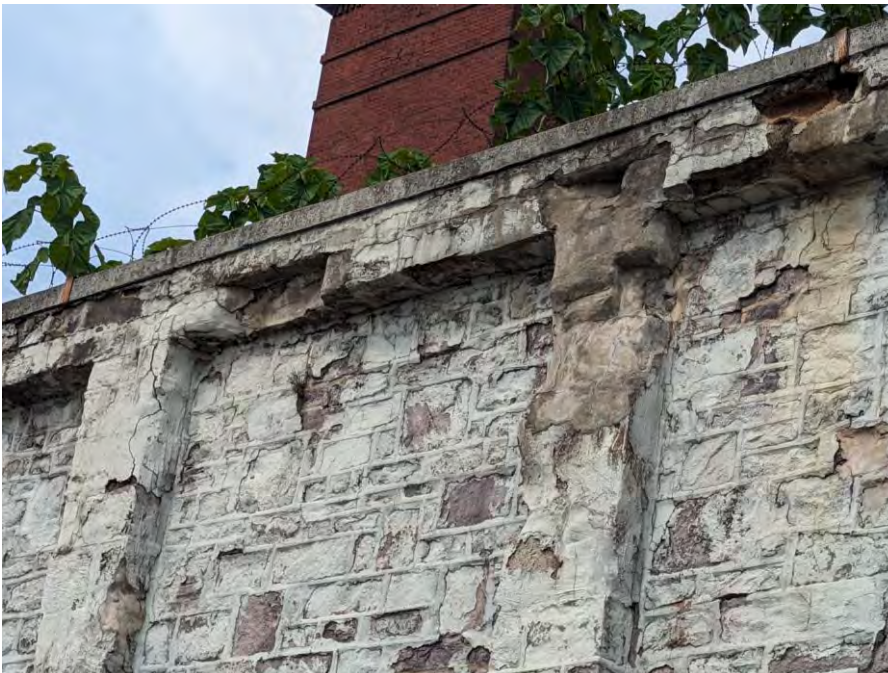
Photo 2

Location: East wall southern end

Description: Wall in *poor* condition, deteriorated stone and loose debris

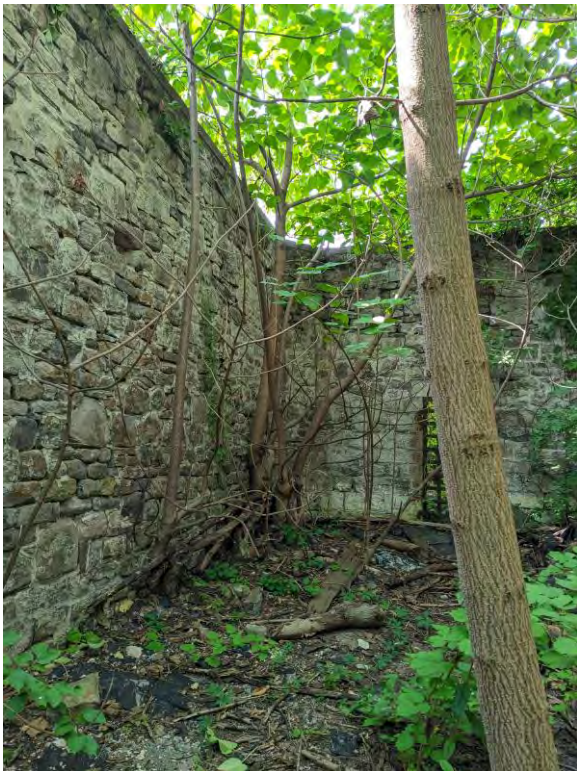
Photo 3

Location: East wall, southern end

Description: Wall in *poor* condition, extensive vegetative growth

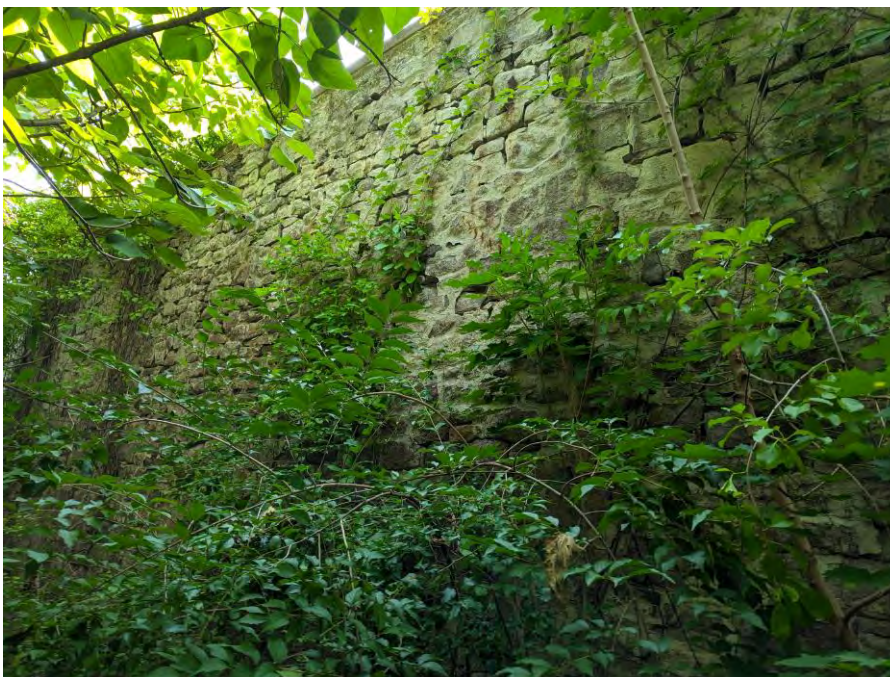
Photo 4

Location: East wall southern end

Description: Wall in *poor* condition, extensive vegetative growth

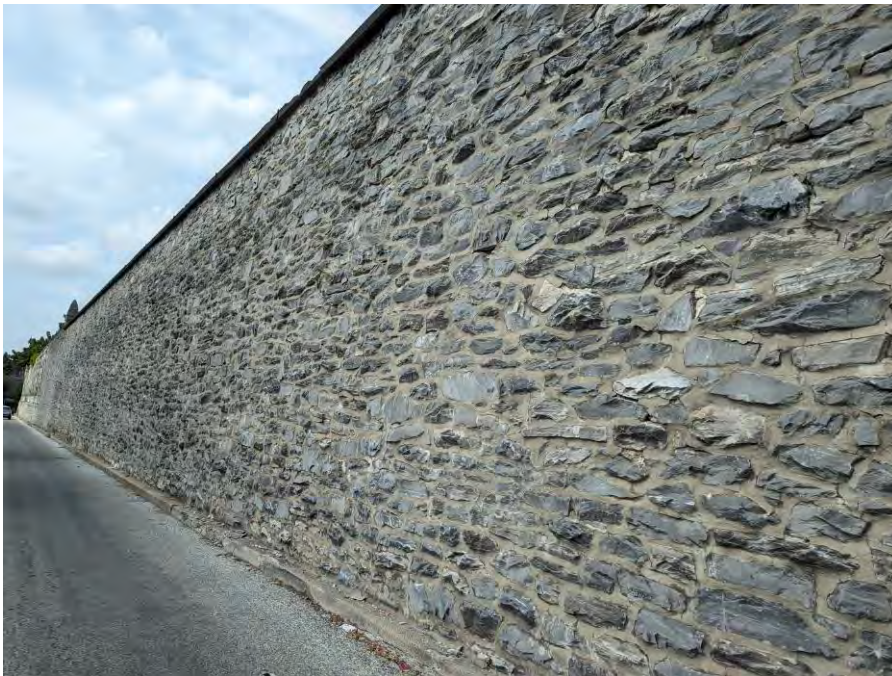
Photo 5

Location: East wall exterior side, northern end

Description: Wall in *average* condition

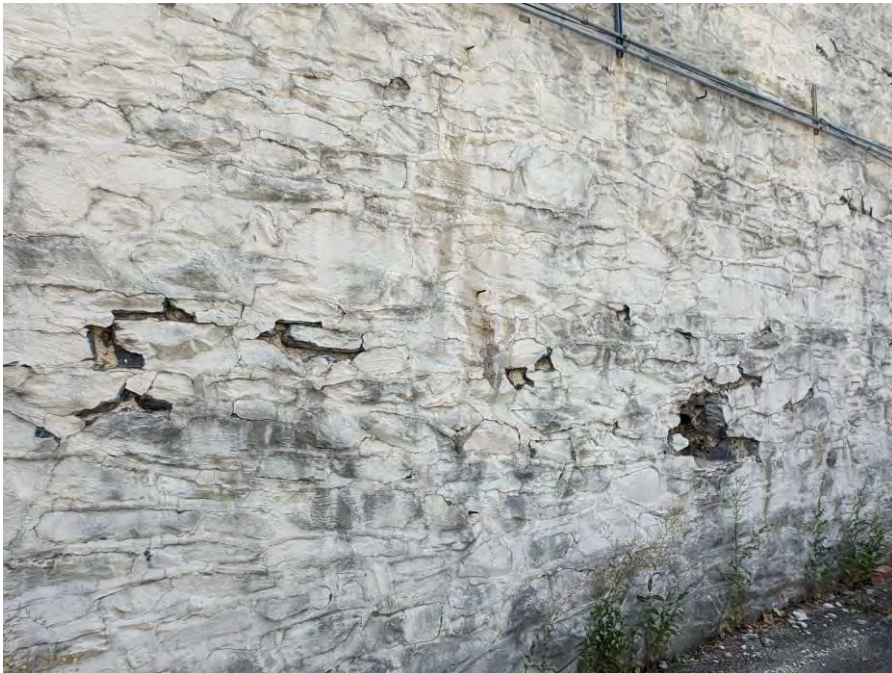
Photo 6

Location: East wall northern end

Description: Wall in *average* condition, spalled repair parging and missing stone

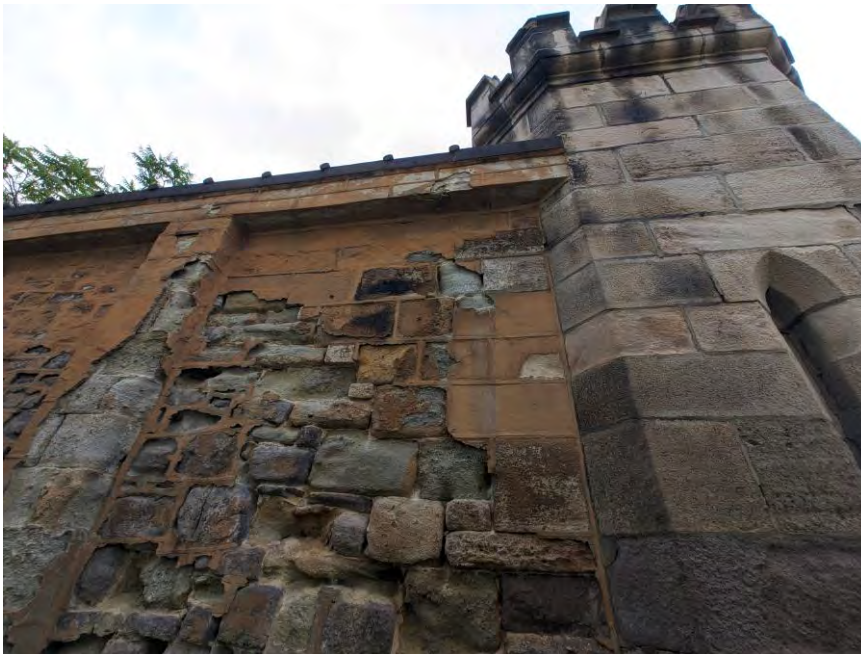
Photo 7

Location: West wall exterior side, south end, Building 1

Description: Wall in *fair*, condition, failing repair parging and deteriorated stone

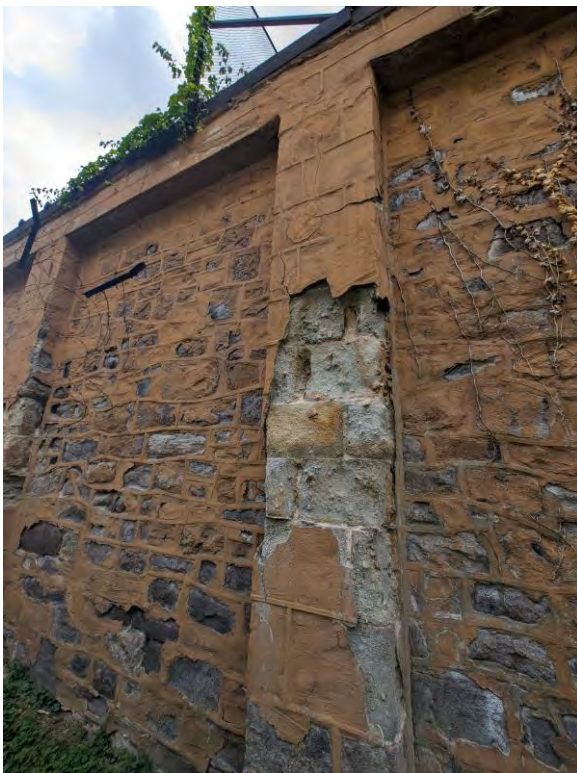
Photo 8

Location: West wall exterior side, southern end

Description: Wall in *fair* condition, failing repair parging and deteriorated stone

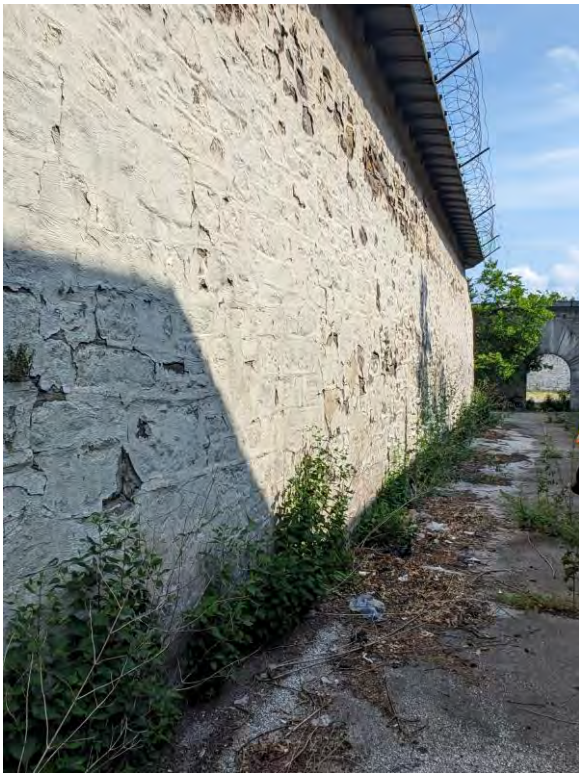
Photo 9

Location: West wall, central

Description: Wall in *average* condition, painted surface deterioration

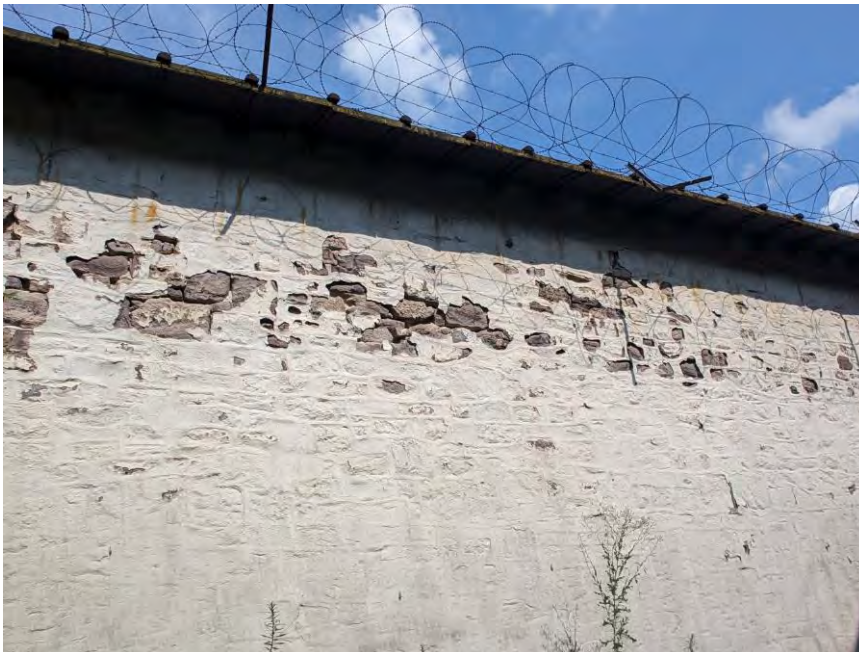
Photo 10

Location: West wall central

Description: Wall in *average* condition, spalled repair parging and missing stone

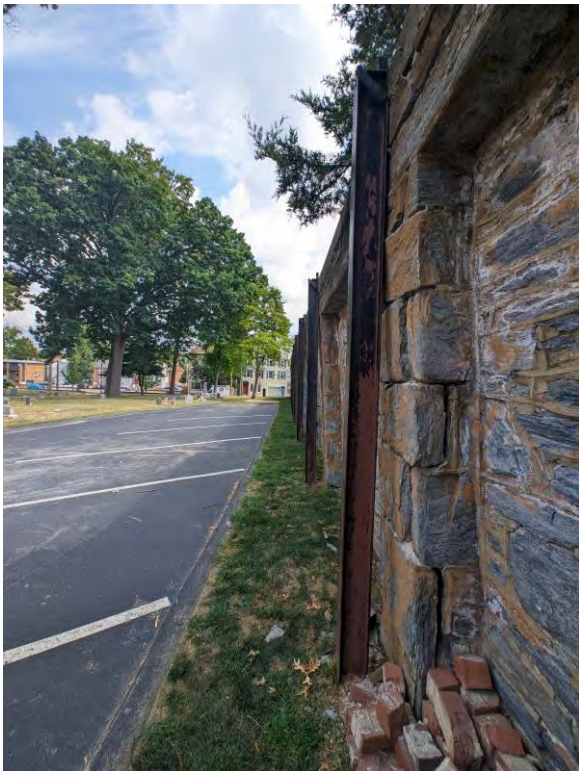
Photo 11

Location: East wall, northern

Description: Wall in *poor* condition, bottom of wall pushing inward toward courtyard, soldier steel pile repair stabilization

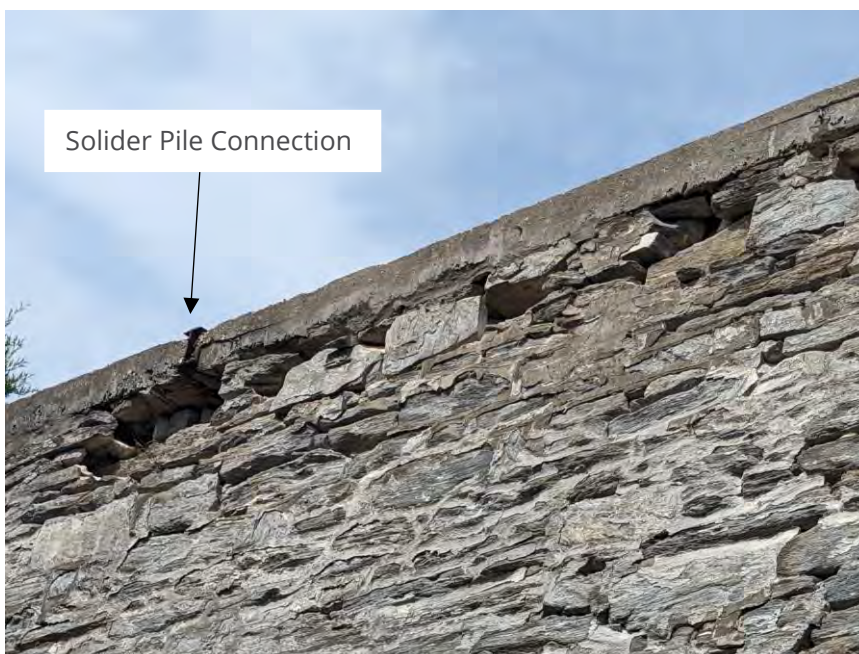
Photo 12

Location: East wall northern end

Description: Wall in *poor* condition, soldier steel pile connection to top of wall deteriorating

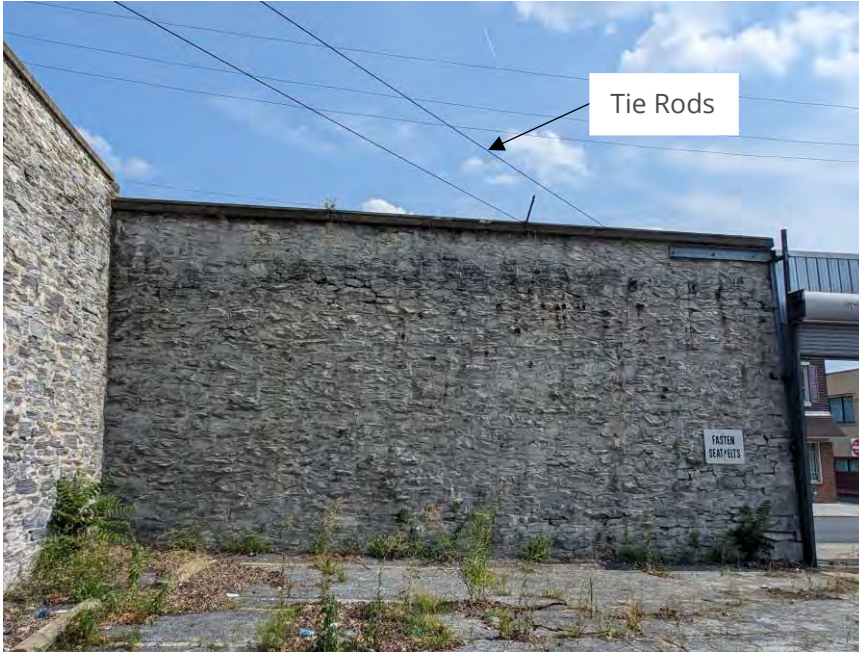
Photo 13

Location: North wall

Description: Wall in *average* condition, horizontal tie rods, unknown purpose

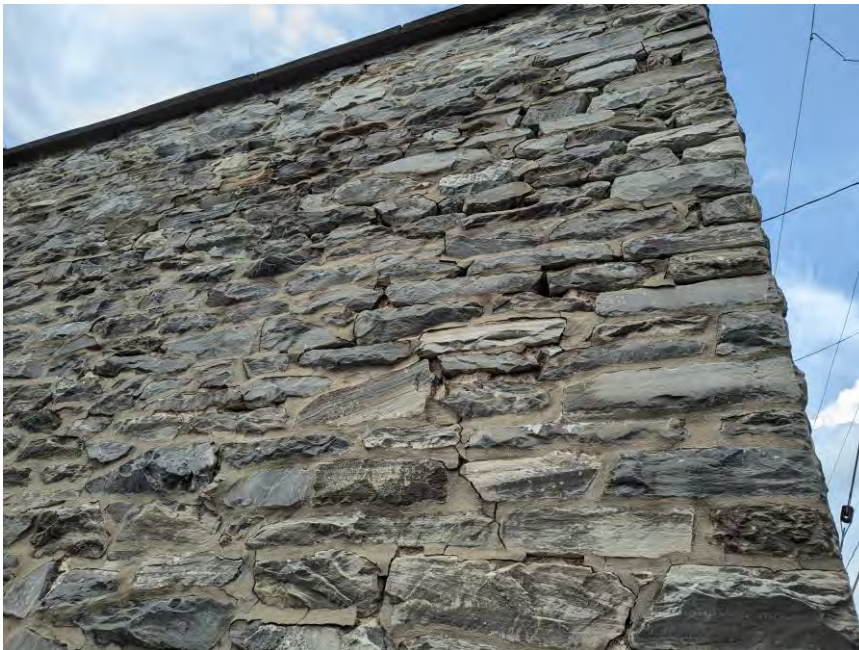
Photo 14

Location: North wall

Description: Wall in *average* condition, spalled repair mortar and cracking

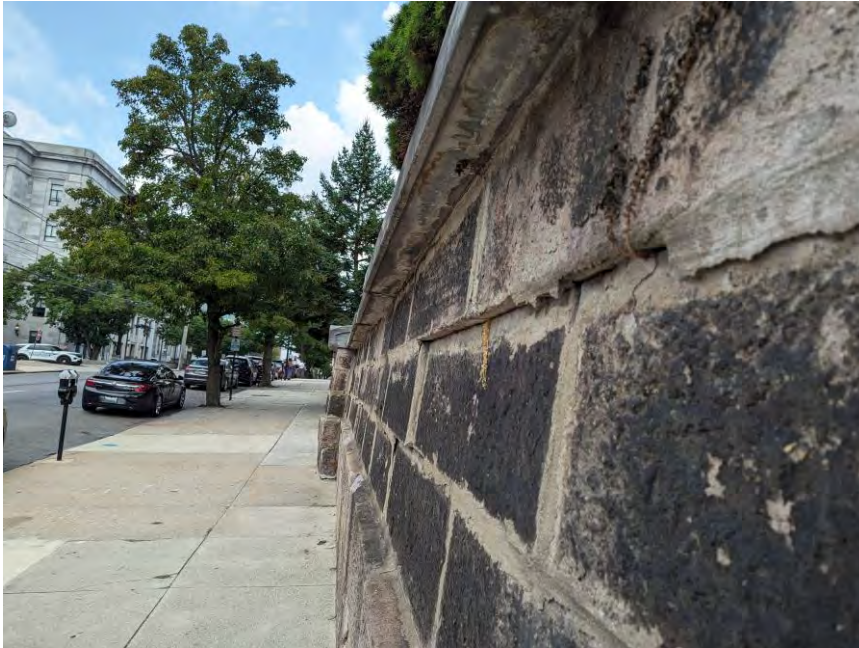
Photo 15

Location: South wall

Description: Wall in *fair* condition, cracking and movement in mortar joint

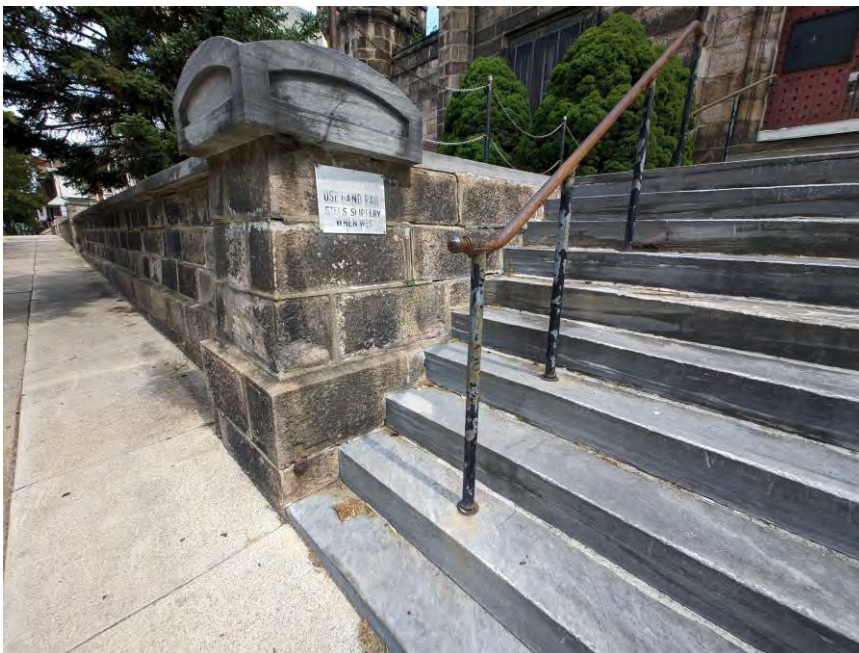
Photo 16

Location: South wall

Description: Wall in *fair* condition

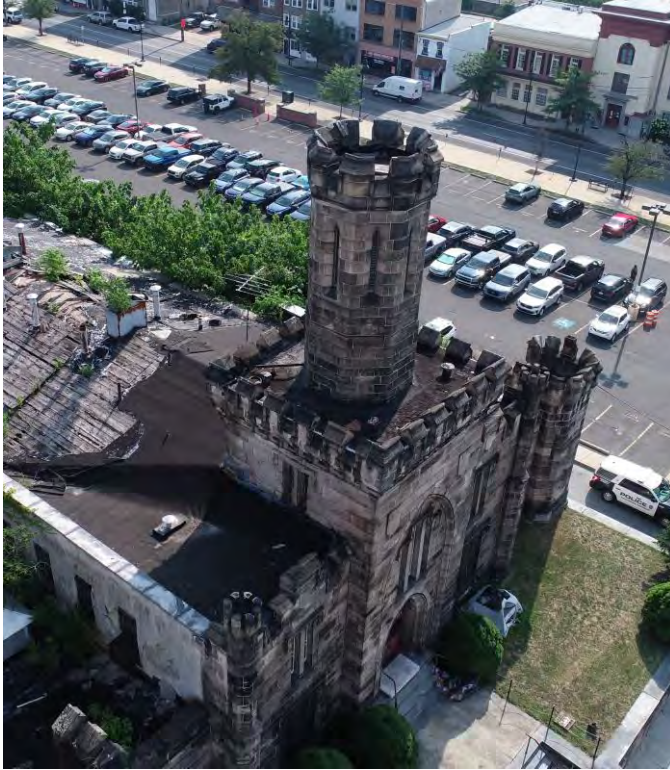
Photo 17

Location: Building 1, South elevation

Description: Stone weathering, *average* condition

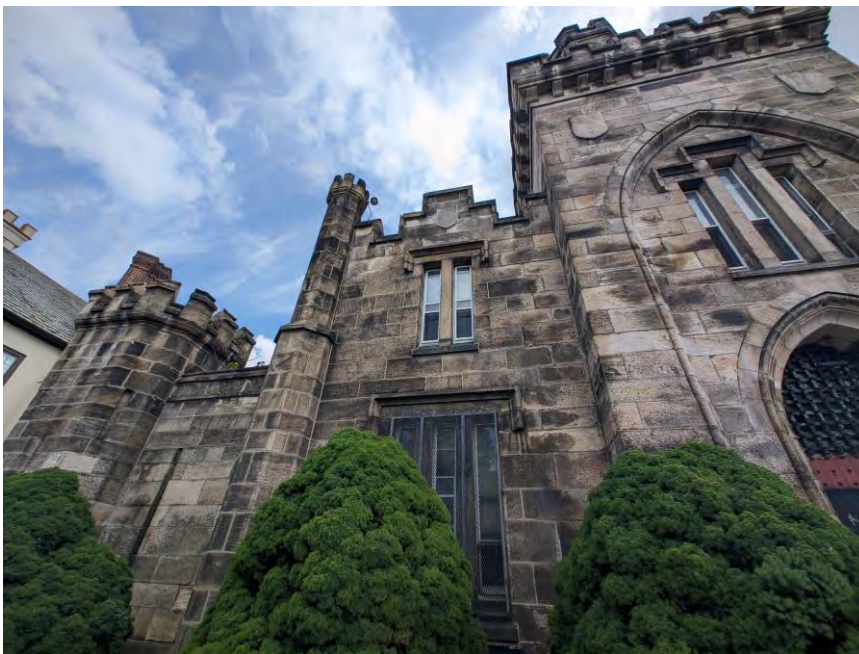
Photo 18

Location: South wall

Description: Stone weathering, *average* condition

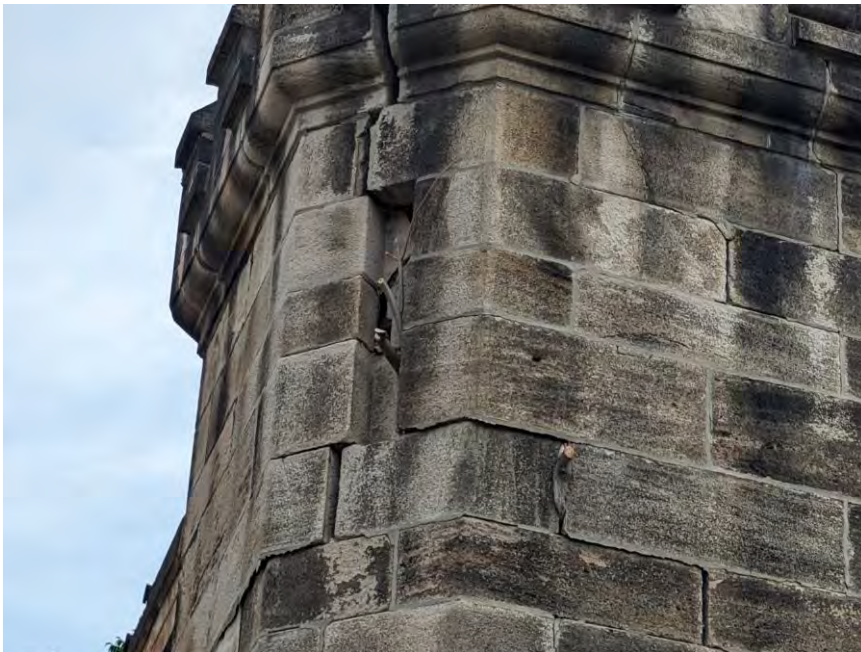
Photo 19

Location: South wall

Description:
Moderate cracking
due to large vegetive
growth in mortar
joint

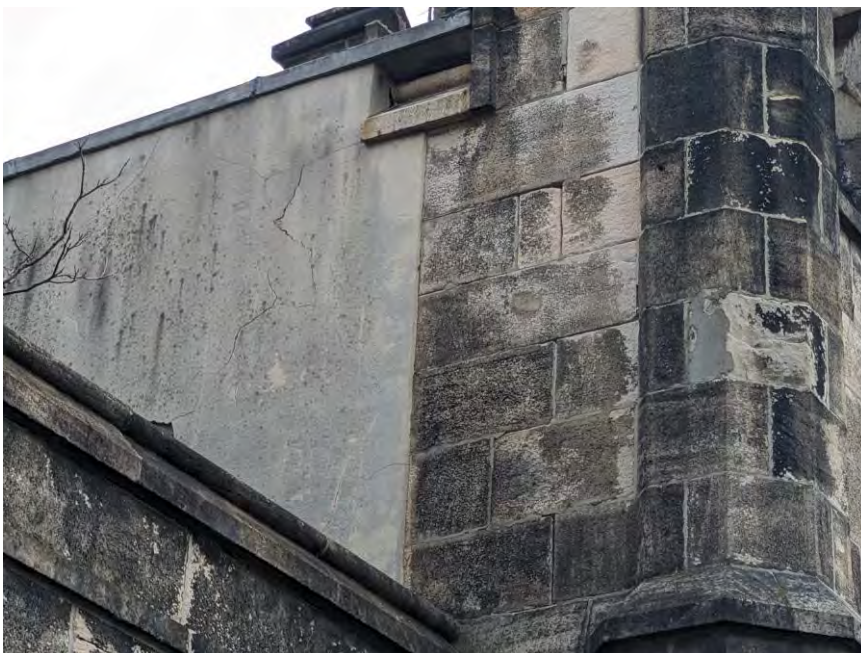
Photo 20

Location: South wall

Description: Stone
weathering, *average*
condition

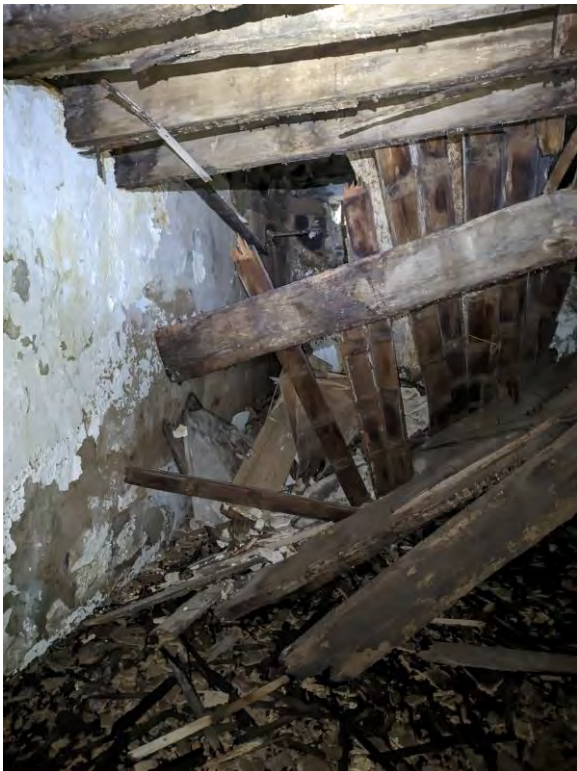
Photo 21

Location: Building 1,
basement

Description: Collapsed wood
floor framing

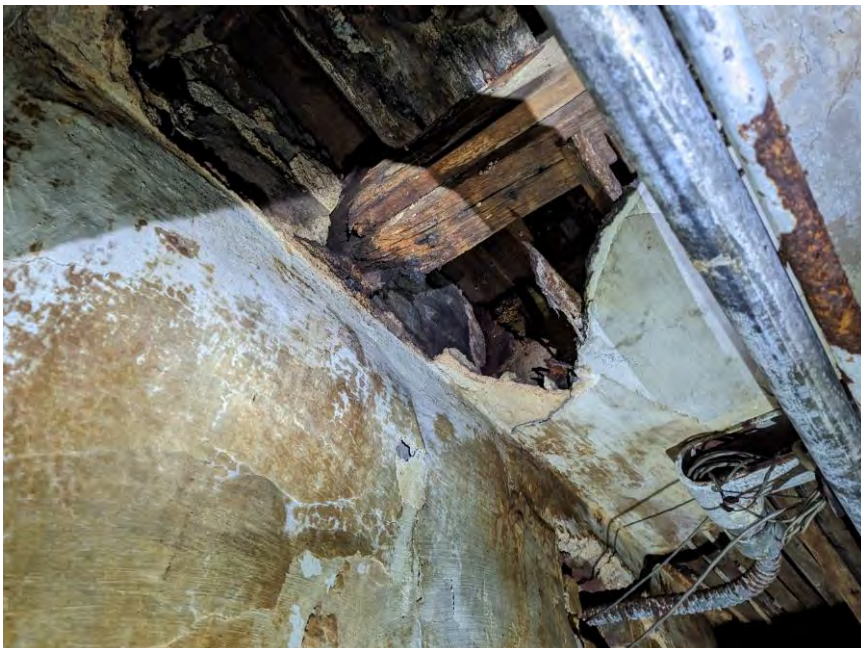
Photo 22

Location: Building 1,
basement

Description:
Collapsed wood
floor framing
deterioration at
bearing pocket

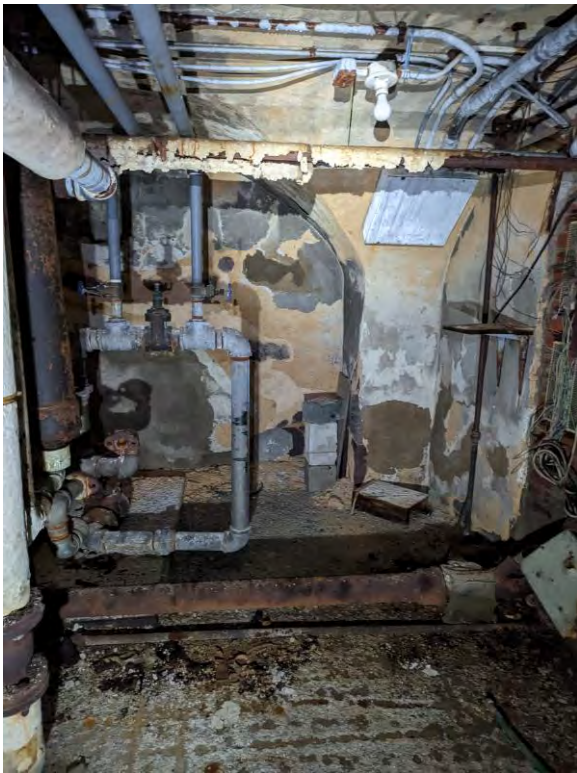
Photo 23

Location: Building 1,
basement

Description: Stone
foundation wall, *average*
condition

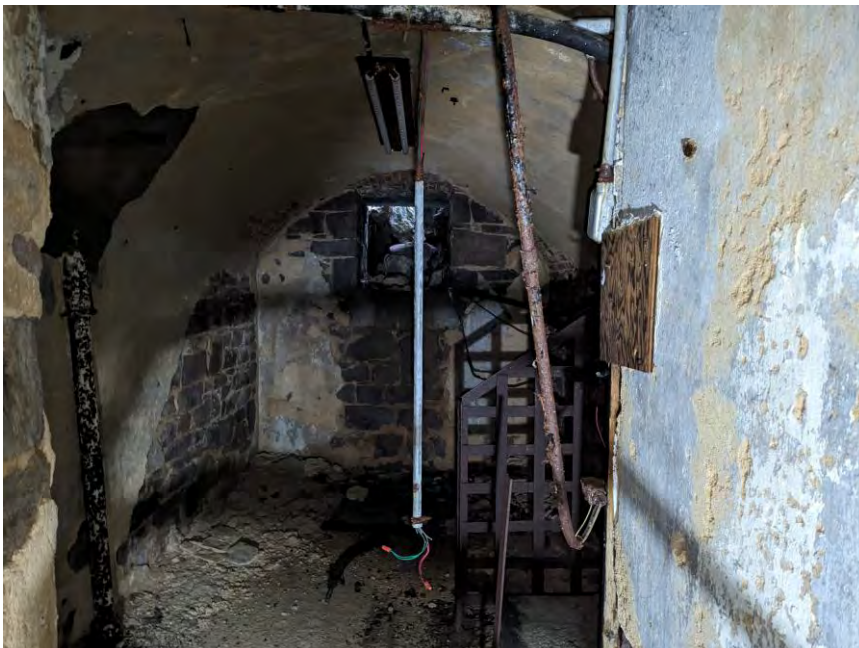
Photo 24

Location: South wall

Description: Stone
weathering, *average*
condition

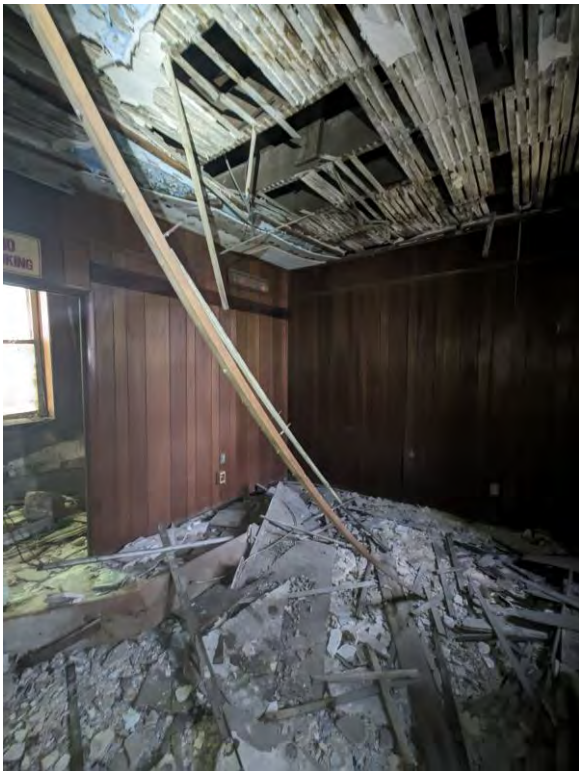
Photo 25

Location: Building 1, first floor

Description: Wood framing in *poor* or collapsed ceiling and floor framing

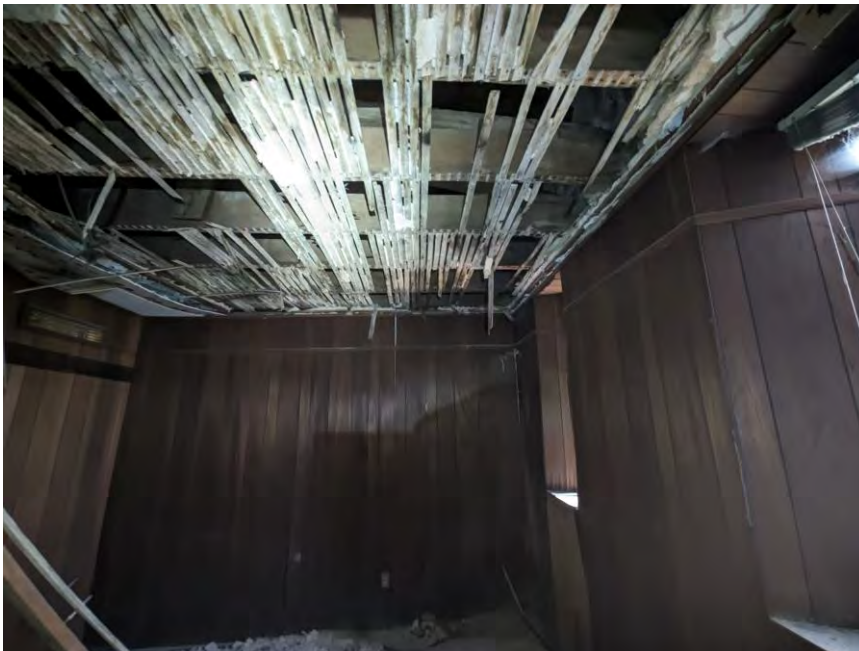
Photo 26

Location: Building 1, first floor

Description: Wood ceiling framing in *poor* condition

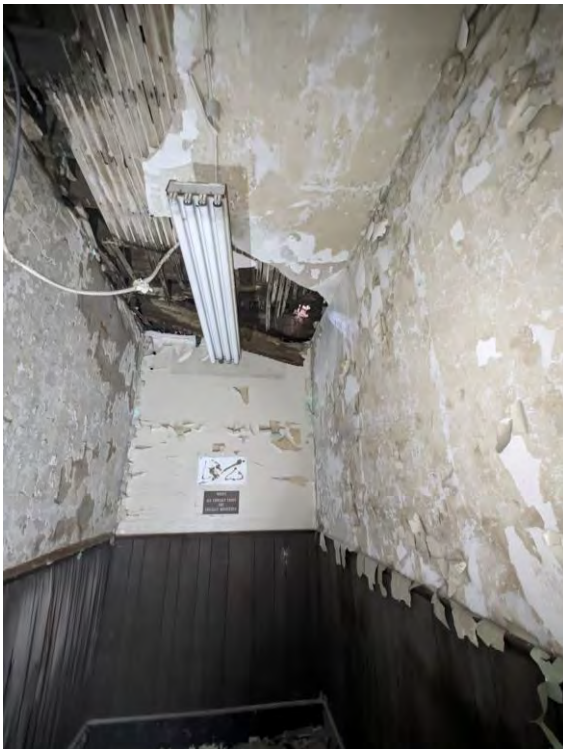
Photo 28

Location: Building 1, first floor

Description: Collapsed ceiling framing

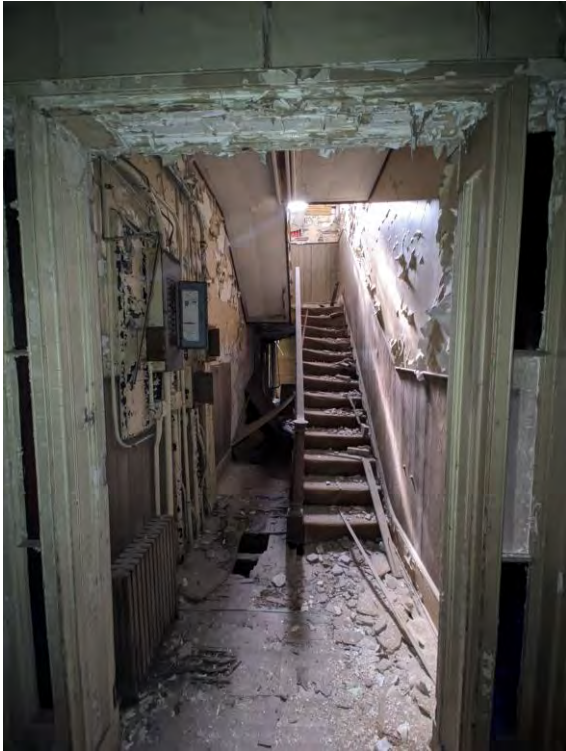
Photo 29

Location: Building 1, first floor

Description: Collapsed wood framed side stairs

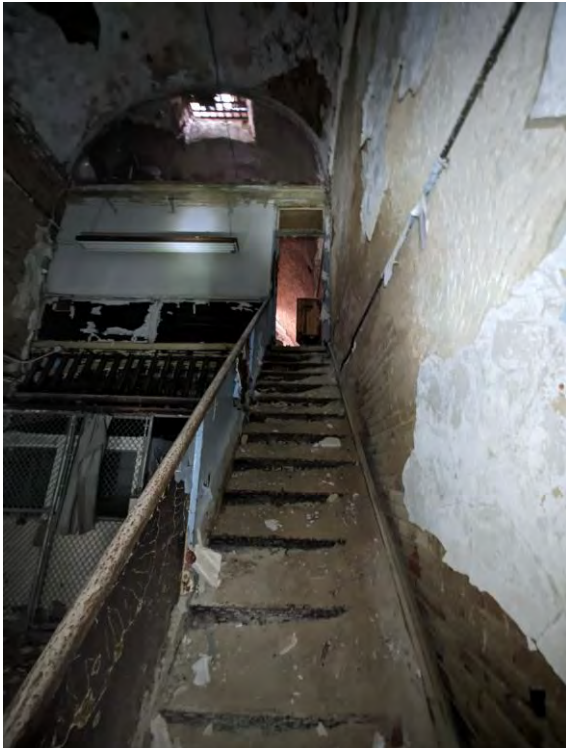
Photo 30

Location: Building 1, first floor

Description: Stone weathering, *average* condition

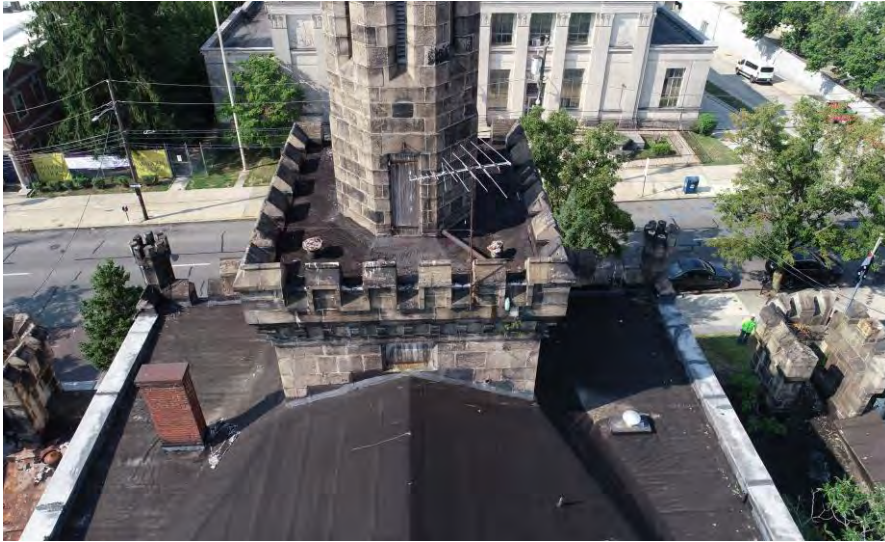
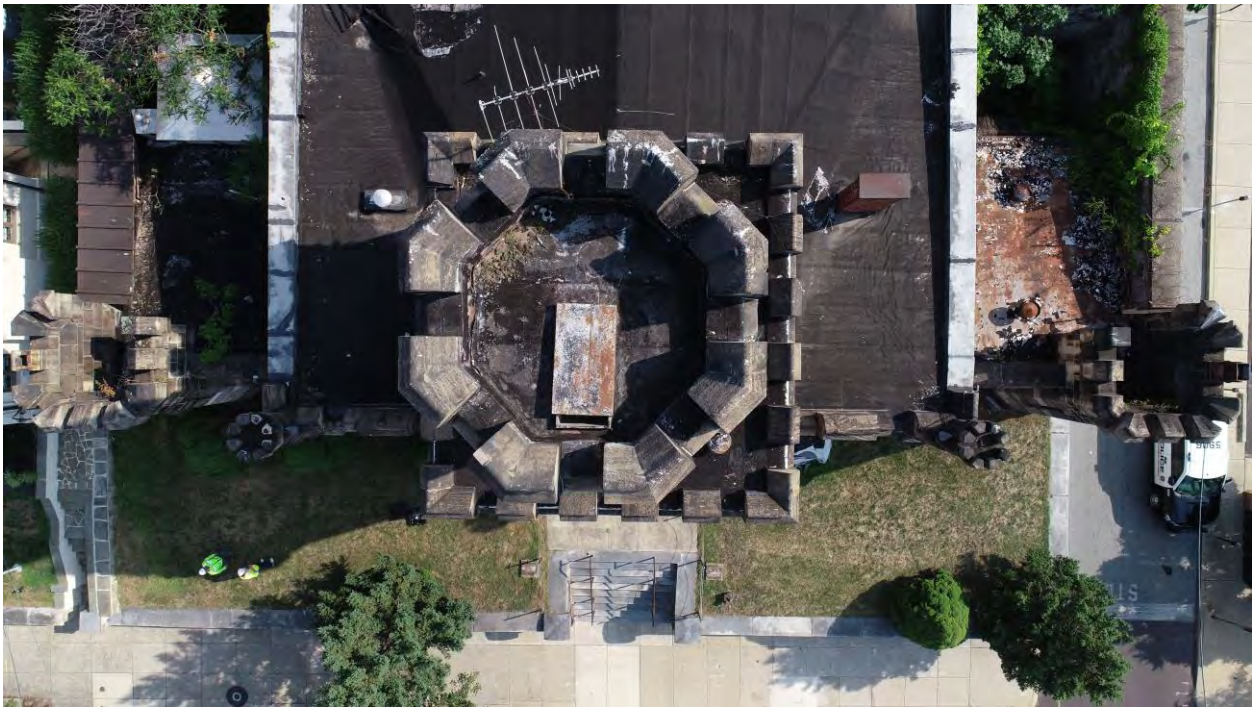
Photos 31 & 32

Location: Building 1

Description: Roof in average to fair condition

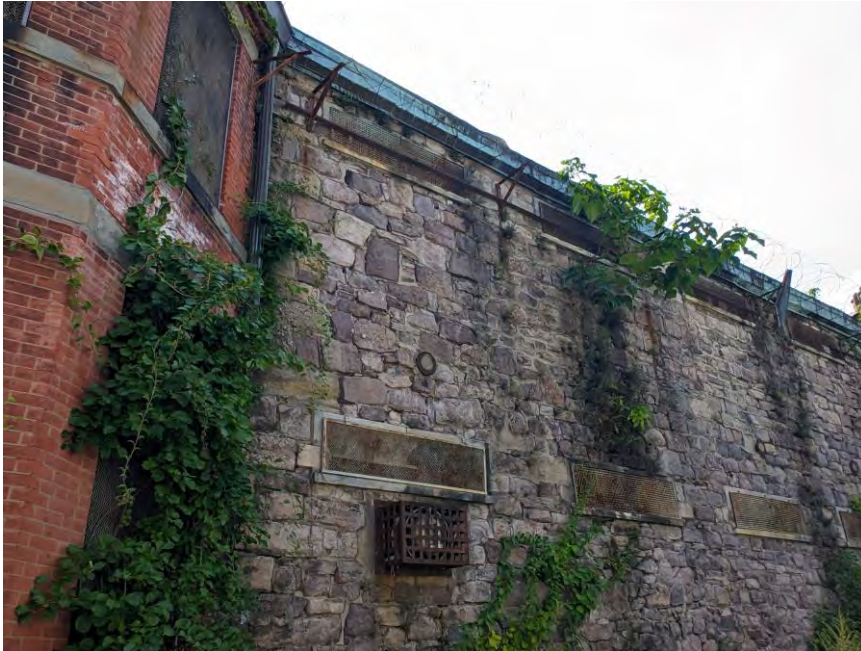
Photo 33

Location: Building 2,
west elevation near
Building 3 (brick)

Description:
Exterior stone wall
with vegetative
growth in fair
condition

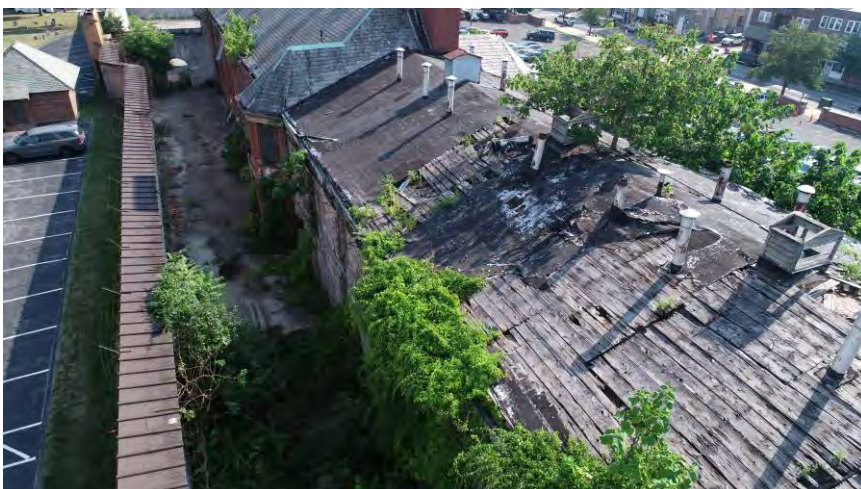
Photo 34

Location: Building 2,
west wall

Description:
Exterior wall with
vegetative growth in
fair condition and
deteriorated wood
roof overlay

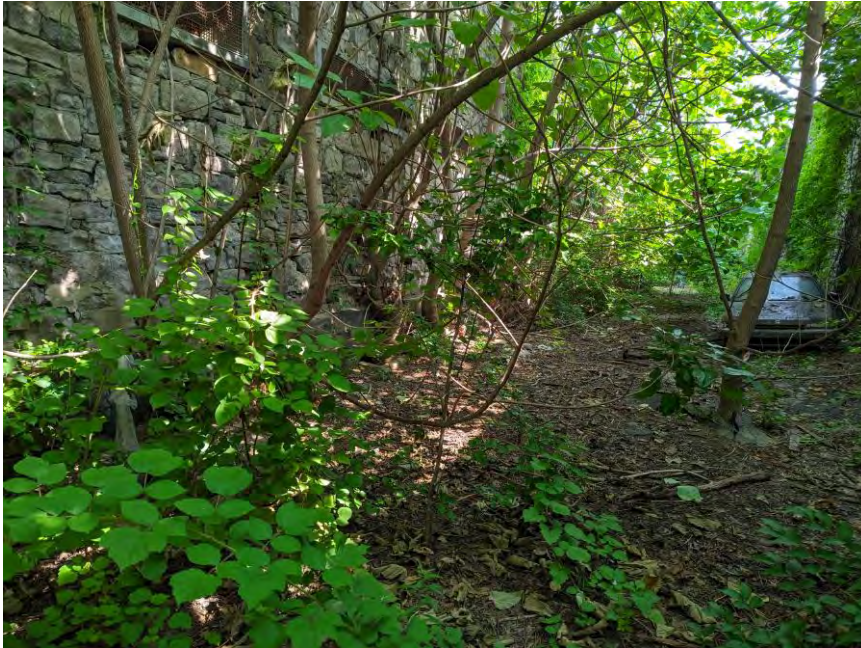
Photo 35

Location: Building 2,
east wall

Description:
Exterior wall with
significant root
growth near grade

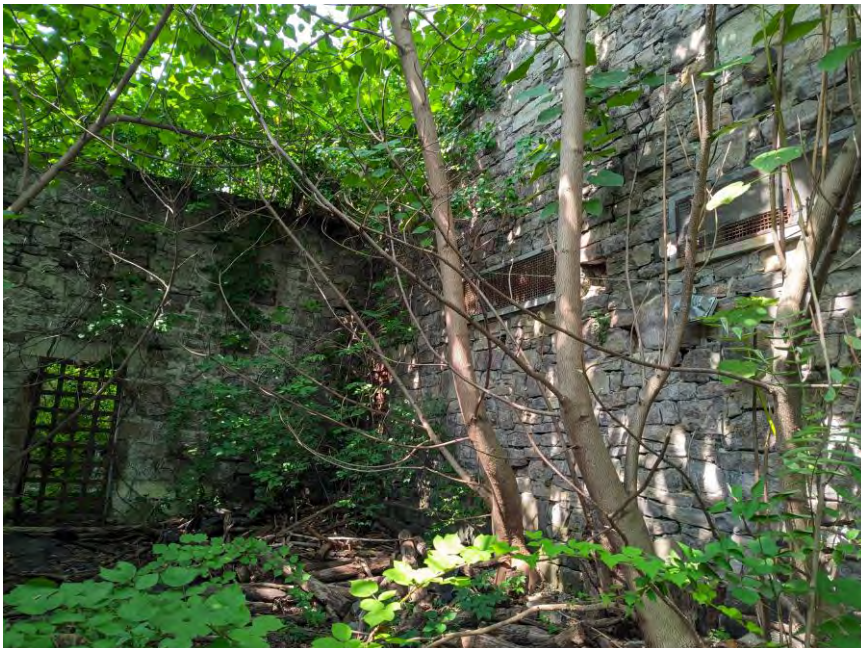
Photo 36

Location: Building 2,
east wall

Description:
Exterior wall with
significant root
growth near grade

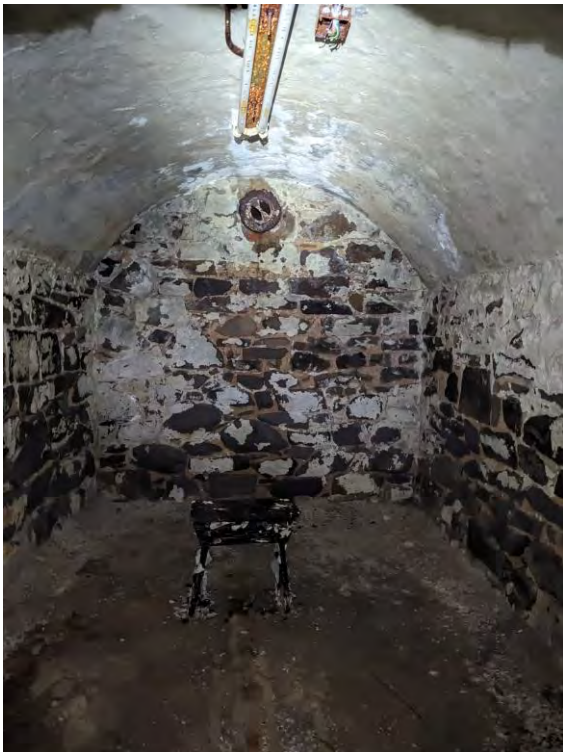
Photo 37

Location: Building 2,
basement

Description: Brick arch
masonry floor construction
on masonry stone bearing
wall in *average* condition

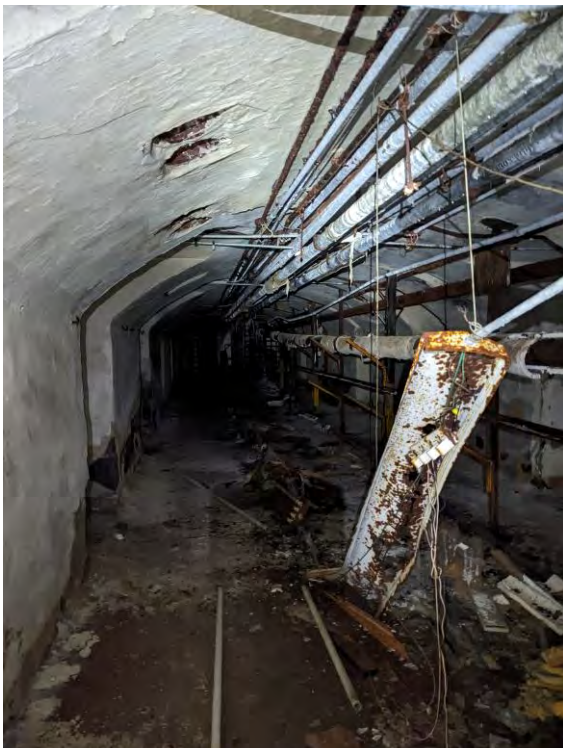
Photo 38

Location: Building 2,
basement

Description: Brick arch
masonry floor construction
on masonry stone bearing
wall in *average* condition

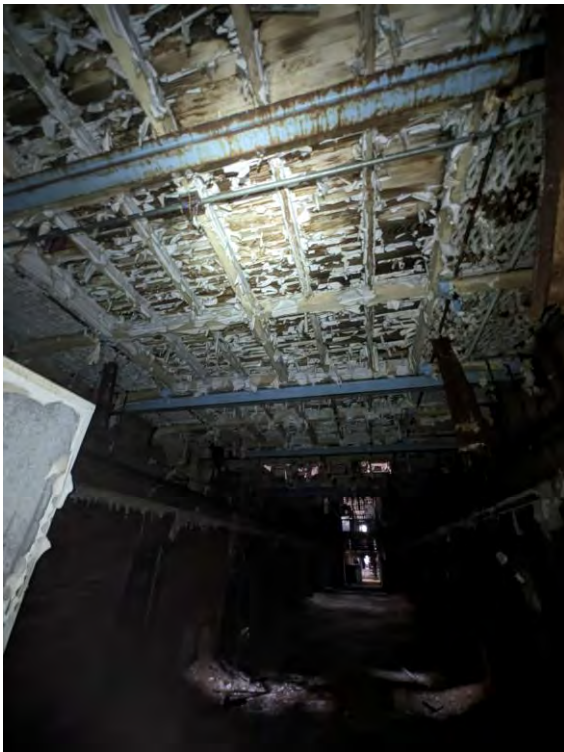
Photo 39

Location: Building 2, first floor

Description: Wood and steel framed cell access floor in *poor* condition

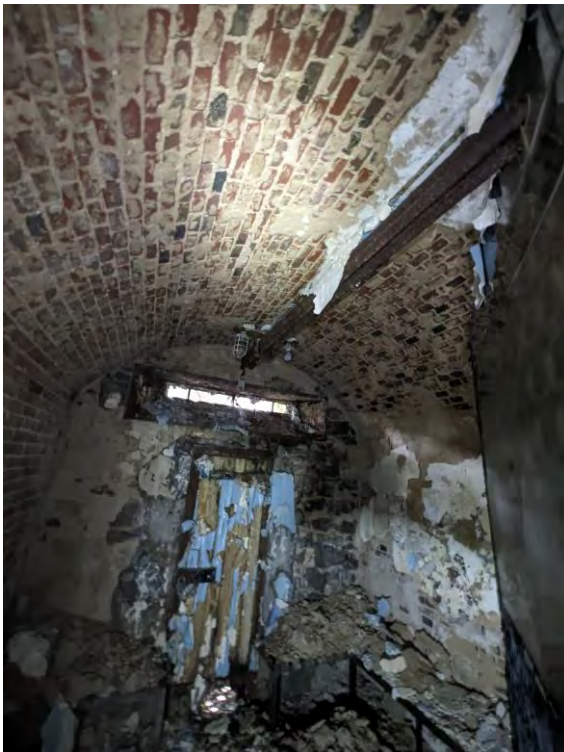
Photo 41

Location: Building 2, first floor

Description: Brick arch masonry floor construction in *average* condition

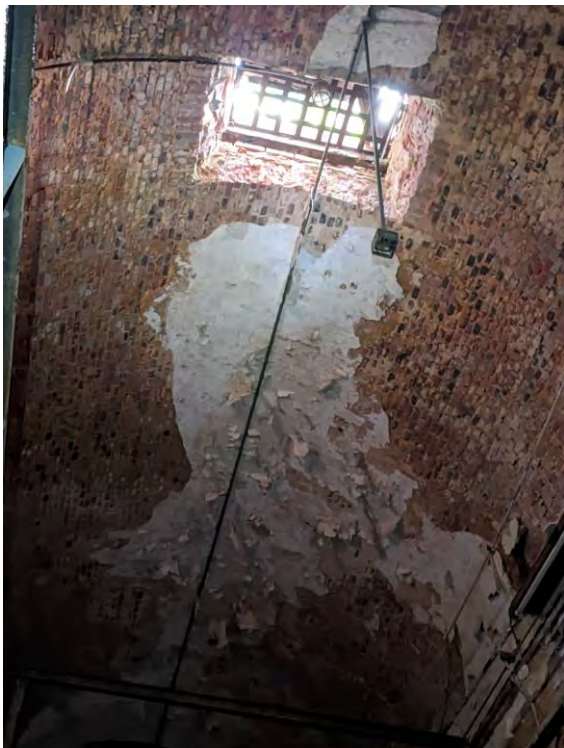
Photo 42

Location: Building 2, first floor

Description: Brick arch masonry roof construction in *average* condition
