APPENDIX D-DEFINITION OF TERMS ASSOCIATED WITH STRUCTURAL CRITERIA EVALUATION AND SITE PHOTOGRAPHS

4.0 YARD AND PERIMETER WALL - REFERENCE PHOTOS

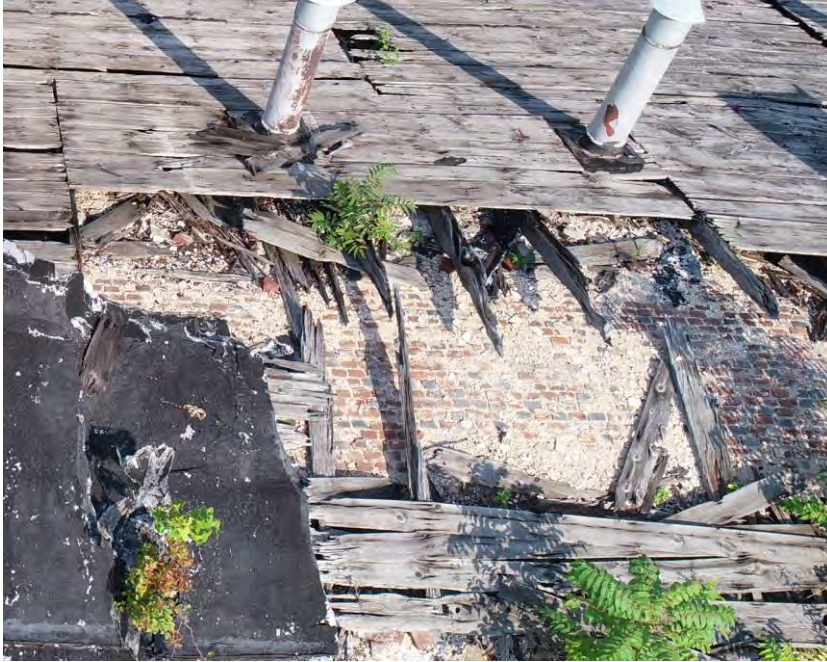
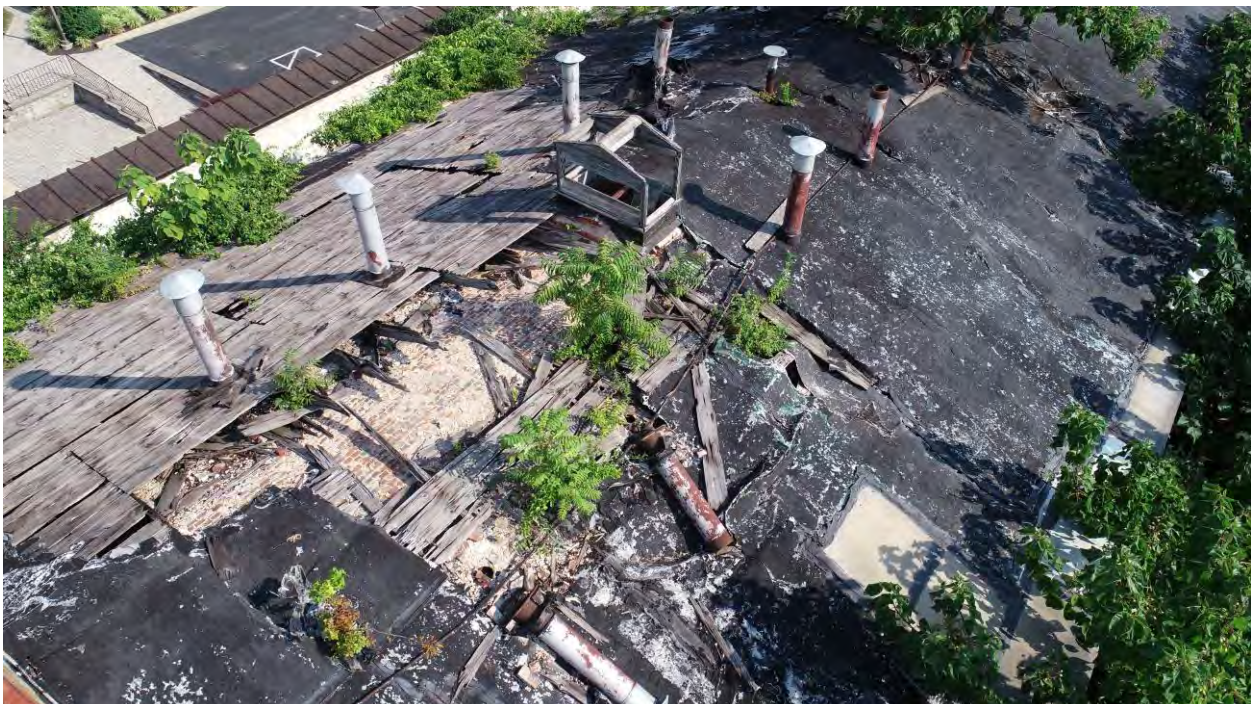
Photos 43 & 44

Location: Building 1

Description: Roof in
average to fair
condition

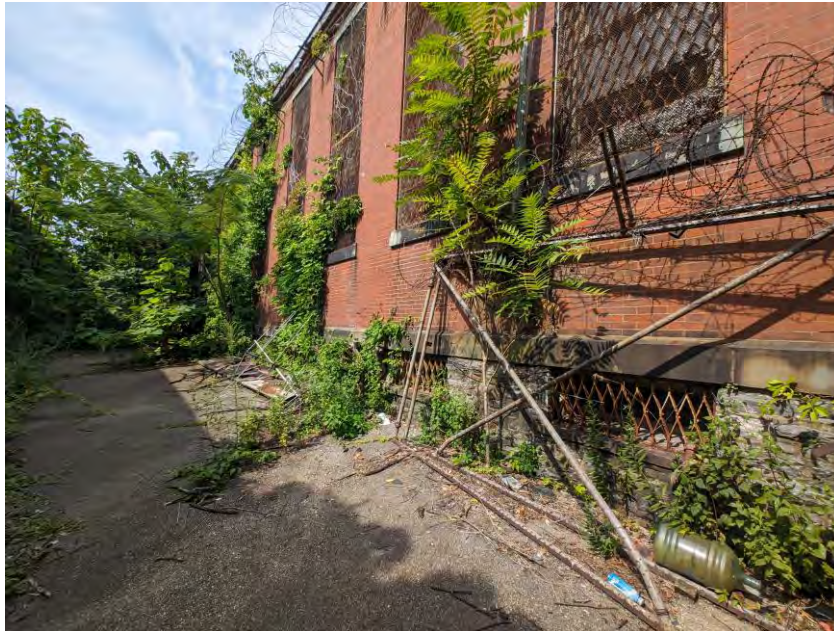
Photo 45

Location: Building 3, east wall

Description:
Moderate vegetative growth along brick masonry bearing wall

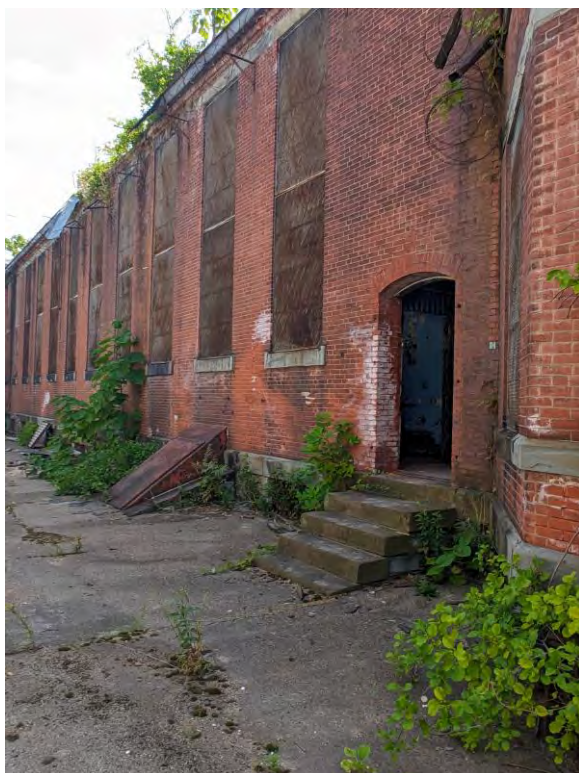
Photo 46

Location: Building 3, west wall

Description: Exterior brick masonry bearing wall in *average* condition

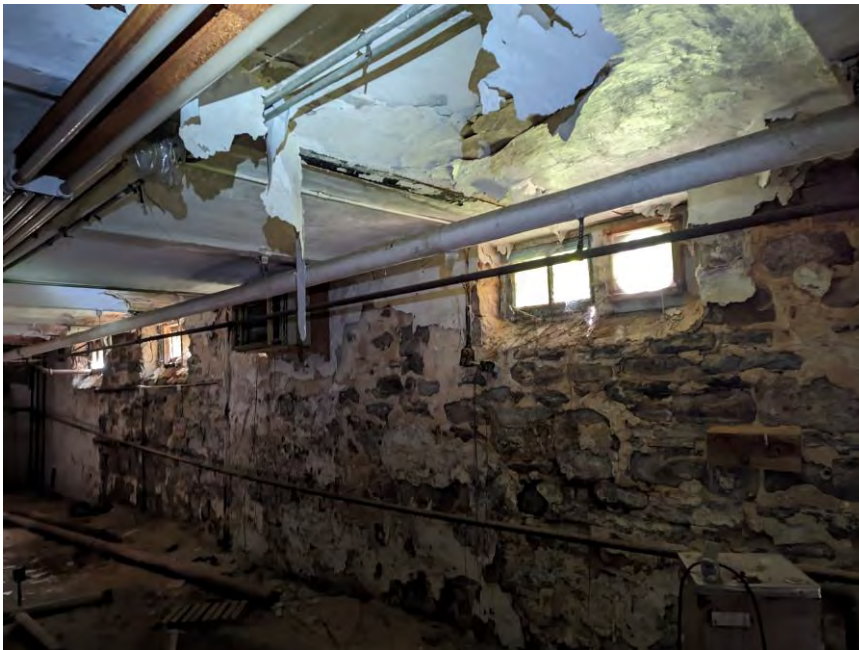
Photo 47

Location: Building 3,
interior east
foundation wall

Description:
Deteriorated parging
and mortar joints,
peeling pain

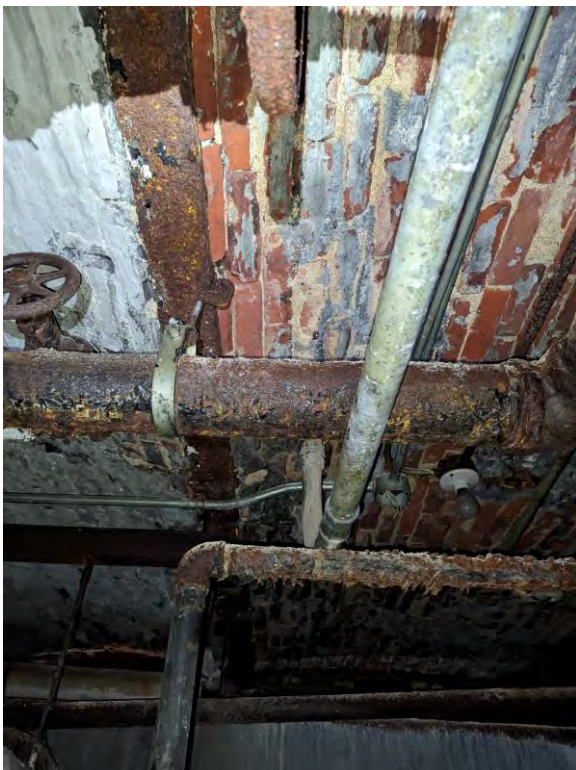
Photo 48

Location: Building 3

Description: Masonry jack
arch first-floor structure in
fair condition

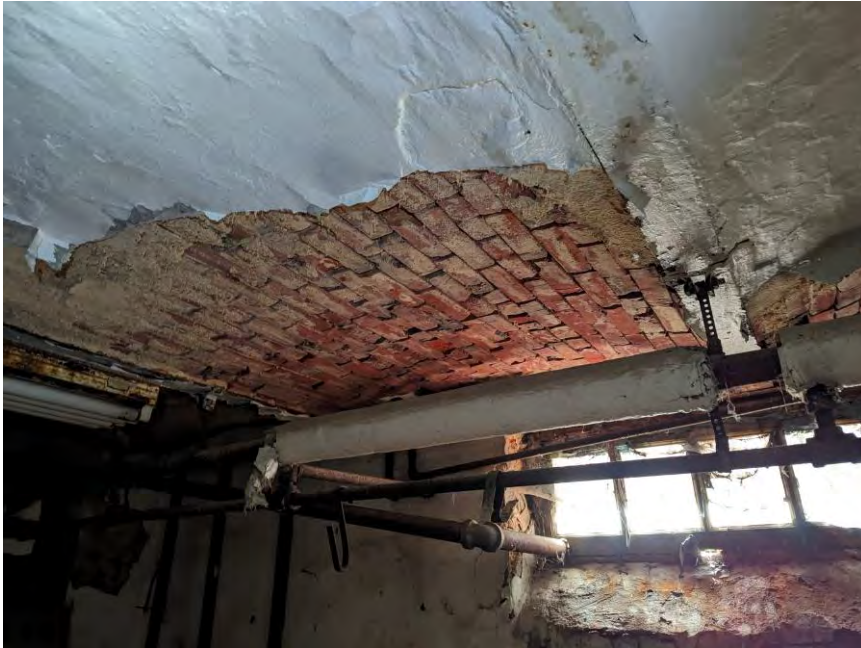
Photo 49

Location: Building 3

Description:
Masonry jack arch
first-floor structure
in *fair* condition

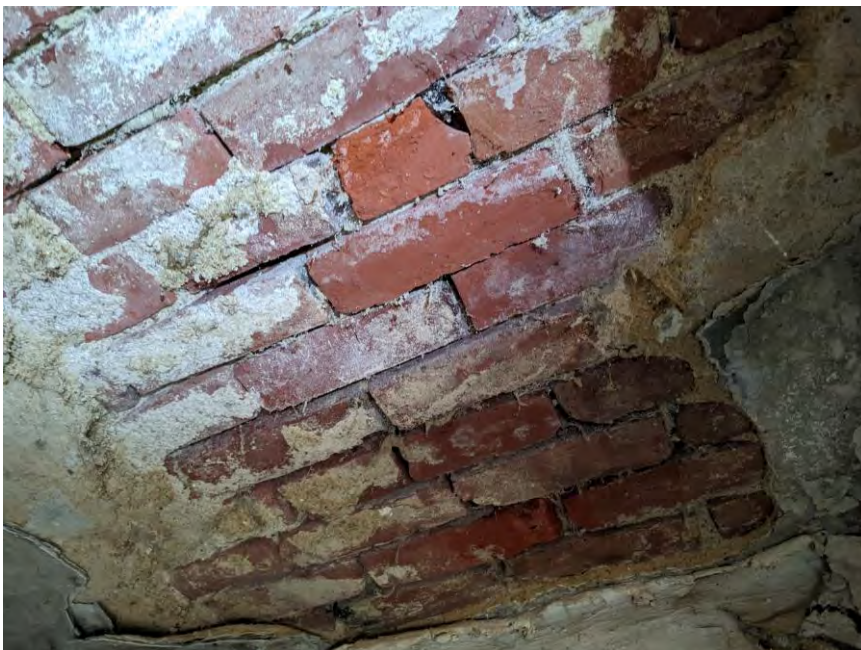
Photo 50

Location: Building 3

Description:
Deteriorated mortar
joints in brick arch
floor construction

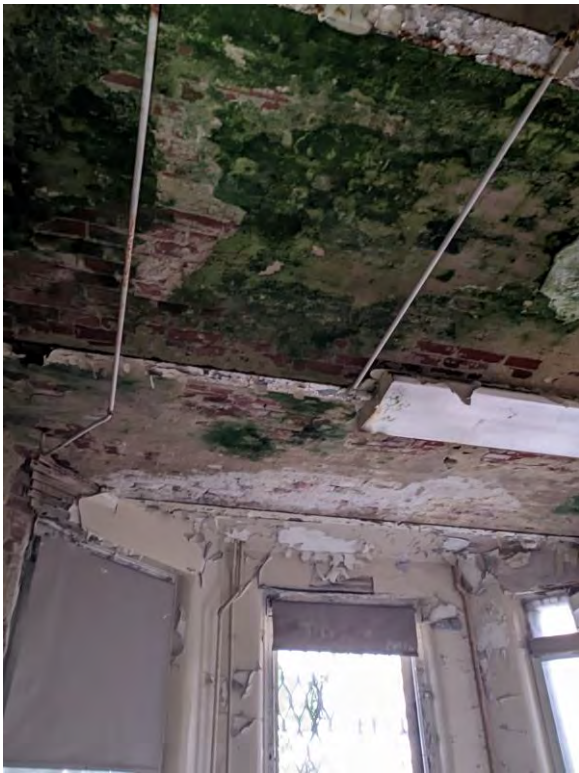
Photo 51

Location: Building 3

Description: Masonry jack arch second-floor structure in *fair* condition

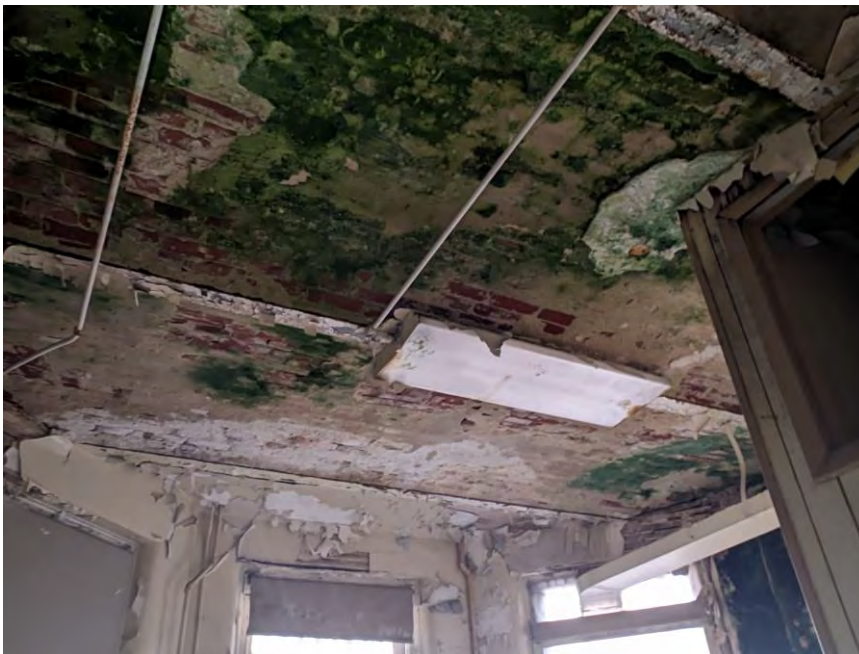
Photo 52

Location: Building 3

Description: Mold and Deteriorated mortar joints in brick arch floor construction

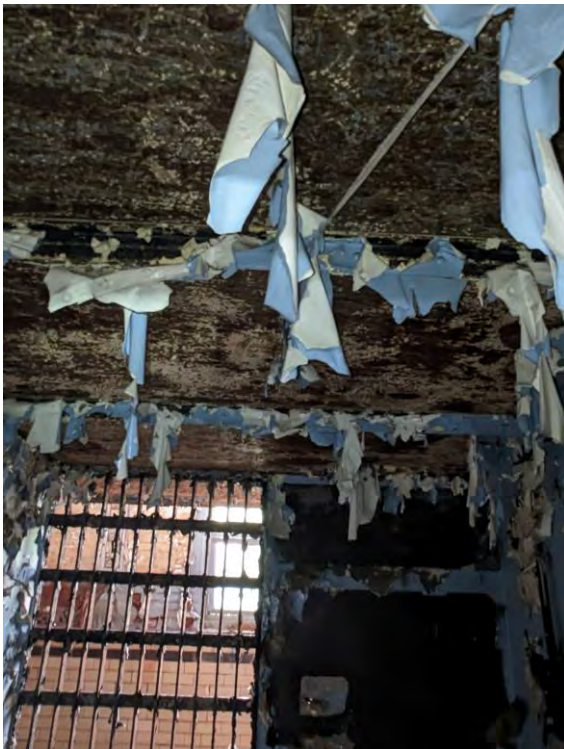
Photo 52

Location: Building 3

Description: Steel-framed cell structure deterioration and peeling paint

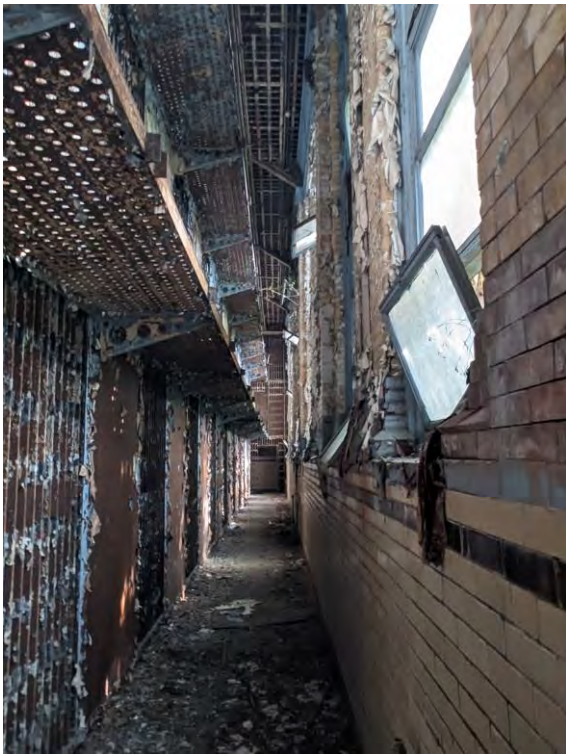
Photo 53

Location: Building 3, along east exterior wall

Description Brick mortar joint deterioration

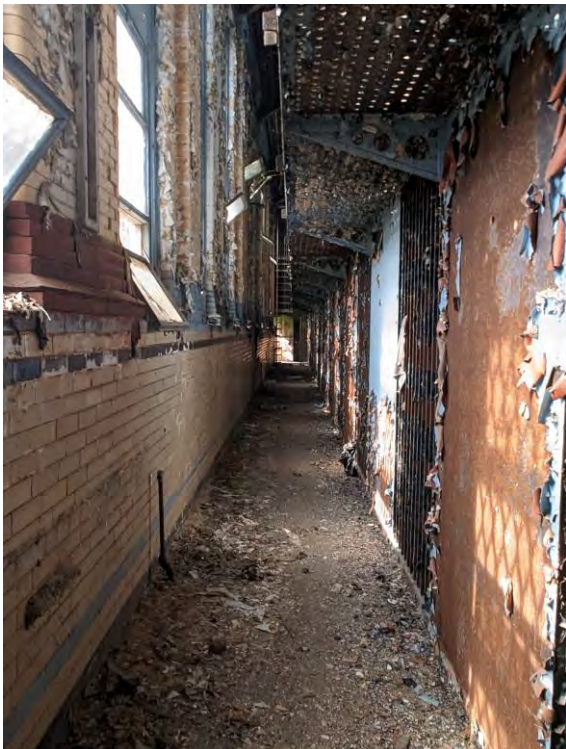
Photo 54

Location: Building 3, along east exterior wall

Description Brick mortar joint deterioration

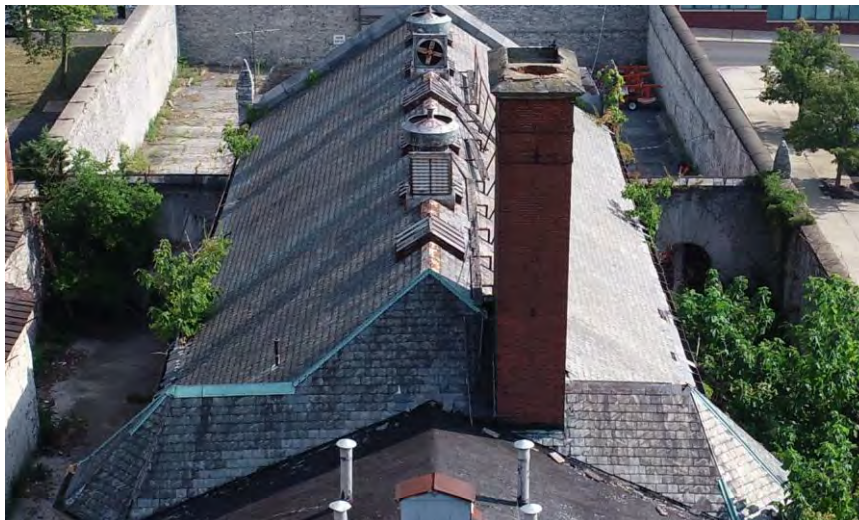
Photo 56

Location: Building 3

Description: Roof in average condition with vegetation in gutters
