# Airy Street Prison Conditions Assessment and Report

November 1, 2024

## Intensive Multi-Disciplinary Conditions Assessment Montgomery County, Pennsylvania

Project No. 24004833A

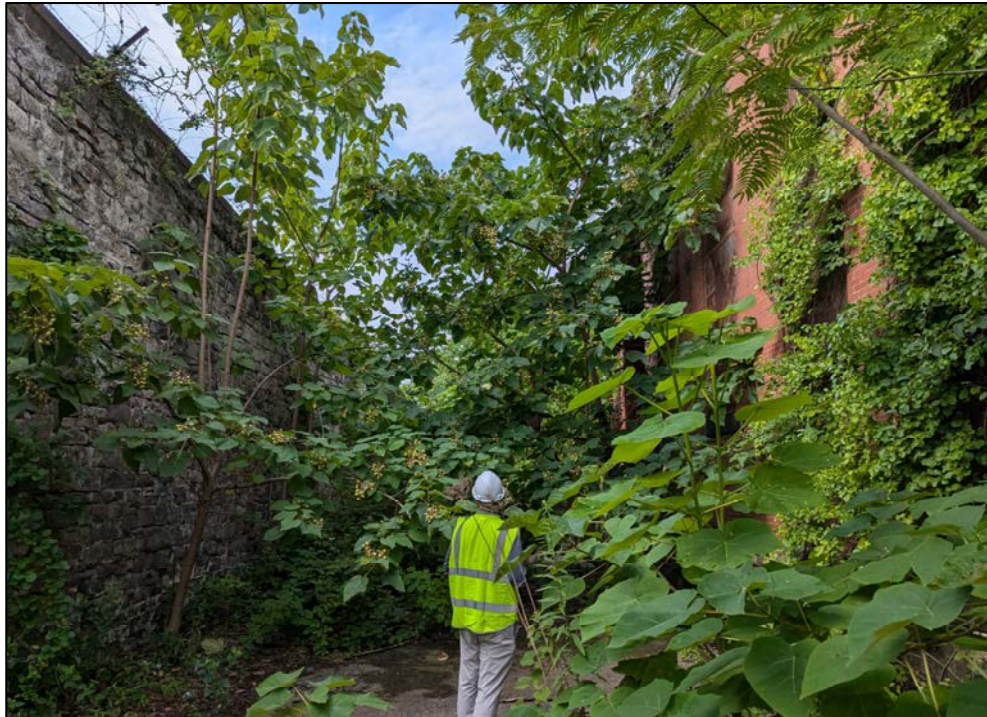
Figure 7. Vegetation within the east yard

Side Yards: The portions of the yard flanking Phases II and III are accessible through large arched openings in the masonry walls on either side of the prison. These yards are also paved with asphalt and are experiencing moderate to heavy vegetation growth. The East yard has heavy vegetation growth, with numerous tree-sized plants growing around and in the Prison building walls.

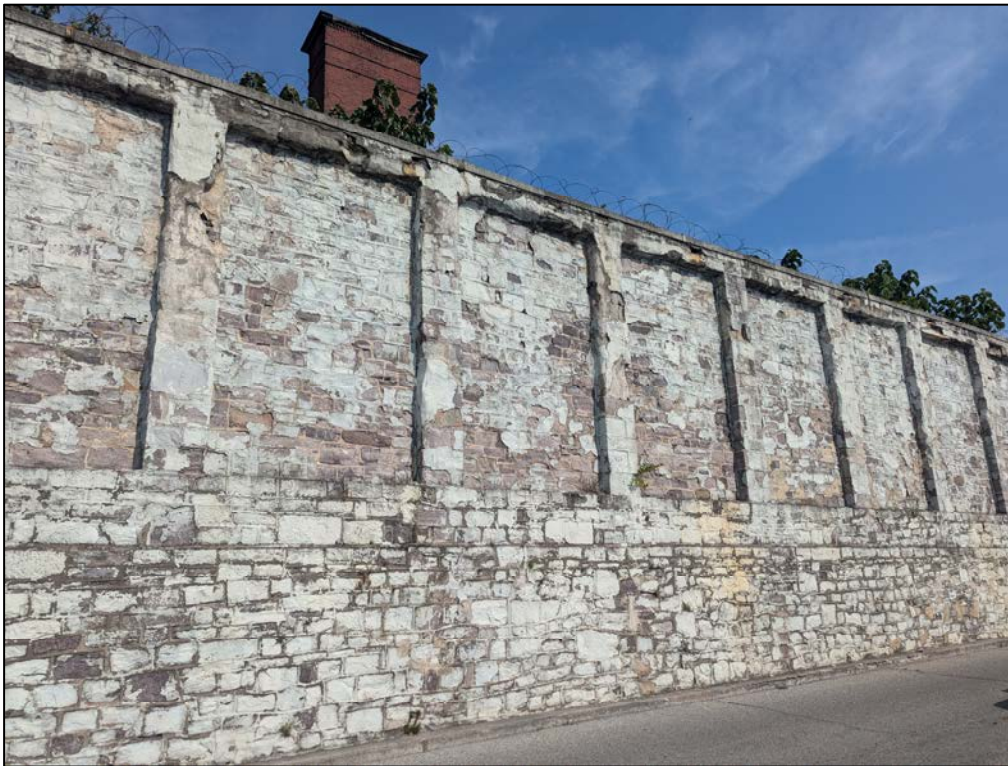
Figure 8. Maris Street perimeter wall showing spalling, west elevation

- The current condition of the wall presents a danger to the public from falling debris by deteriorated stone along Maris St. The wall should be made safe and monitored for further degradation.

- The steel pile repair at the Northwest is nearing the end of its useful life and in need of monitoring or repair/ replacement.
- If the wall is removed as part of future development, portions serving as a retaining wall must be replaced.

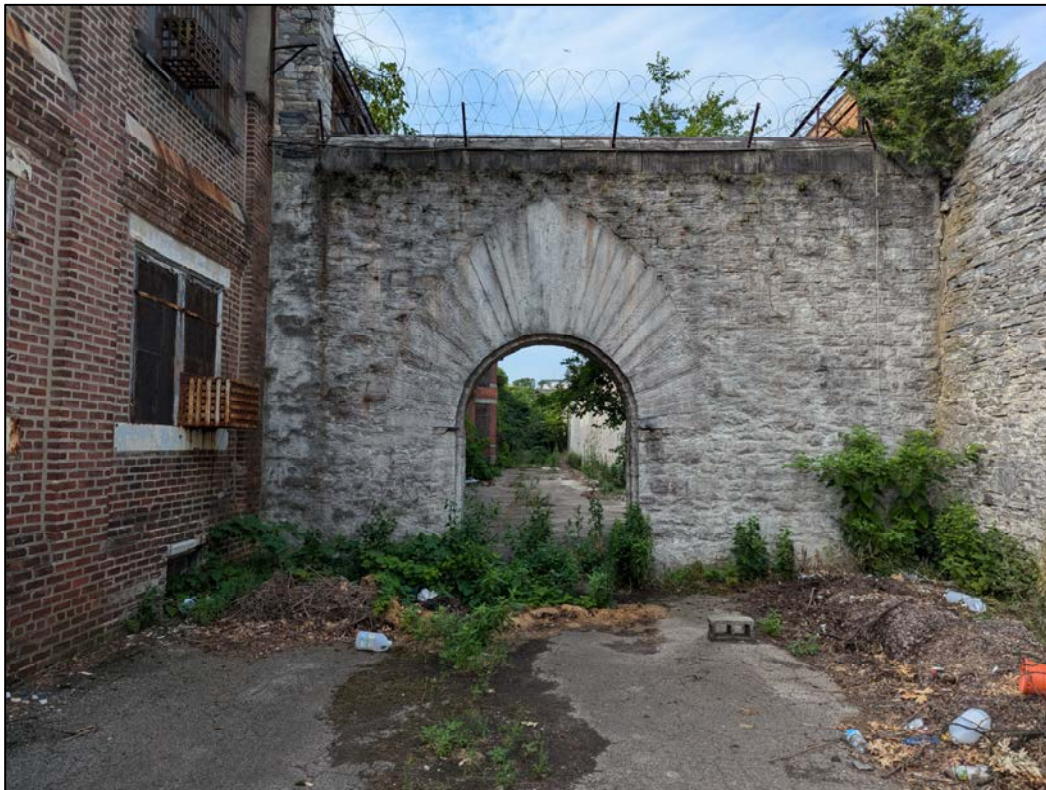
- Prison walls are intentionally and notoriously difficult to penetrate and could present a site access challenge for construction equipment.
- Assuming site access is reached through the existing rear gate on Marshall Street, the existing interior stone prison wall separating the prison yards between Phases IV and III features 7'-5" x 10'-8" (6'-5" at low point of arch) arched openings. For example, during CED's investigation, a typical geotechnical rig could not fit through the existing openings. Heavy construction equipment will likely face a similar challenge. Small equipment or a system to hoist large equipment over the wall may be needed for construction.

Figure 9. East Prison Wall Arch, View South

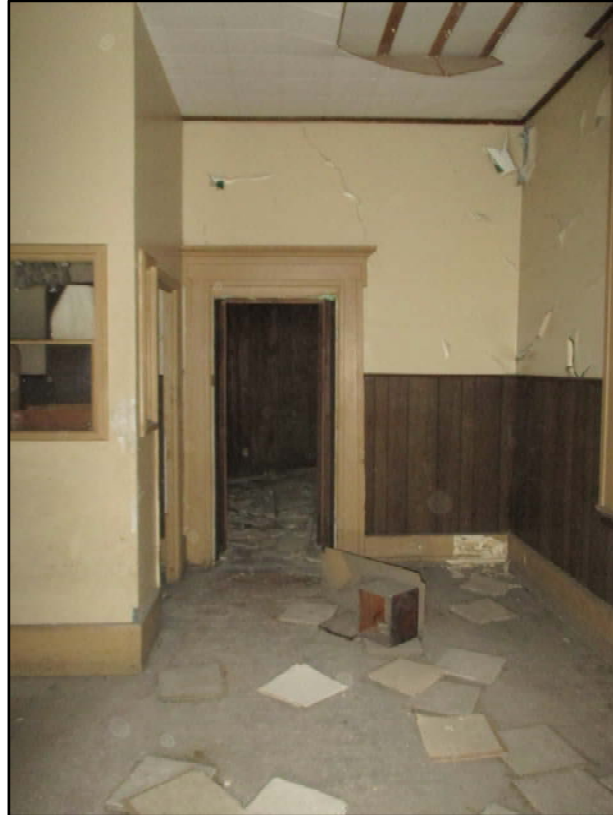
The foundation and interior masonry brick and stone walls are in *average* condition. Most areas have been plastered or parged. Where exposed, the surface of the stone and brick is in *average* condition. Some mortar deterioration and loose stone or brick are present.

Figure 11. Phase I Interior

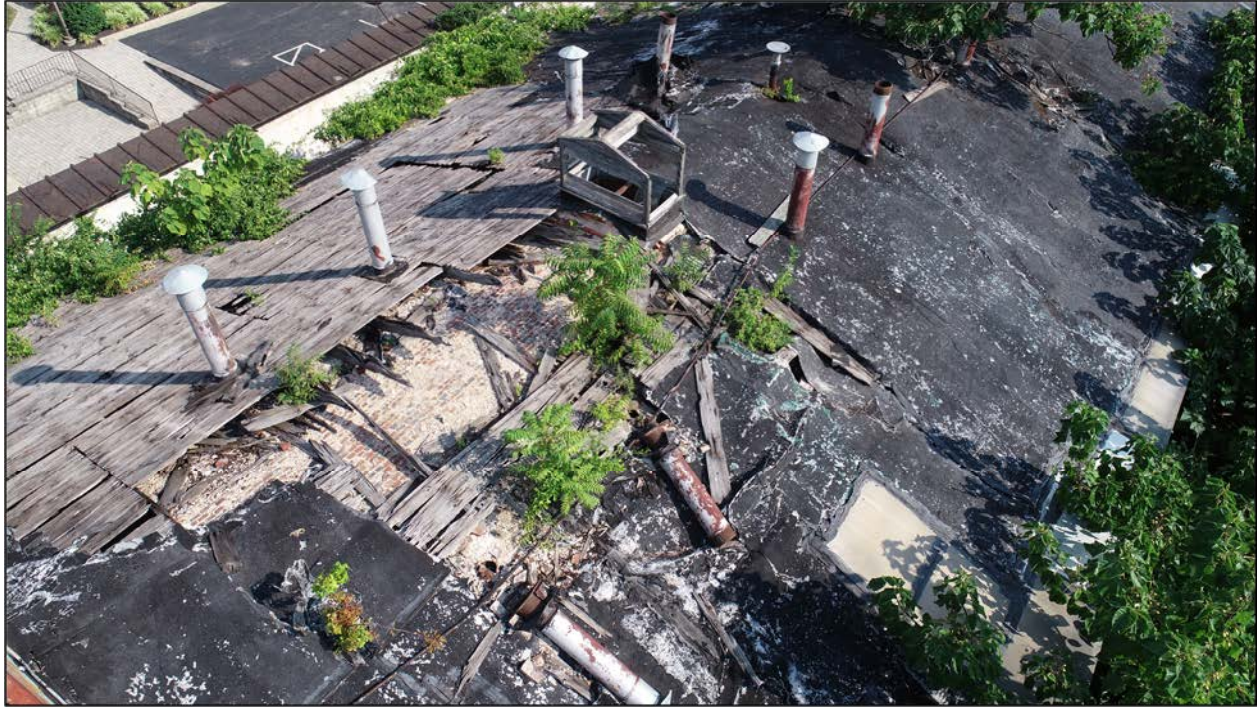
Figure 14. Phase II Roof

The general condition of the roof structure appears to be fair. While the main brick arch structure over the central area appears to be in average condition, the wood over-framing above the arch roof has incurred moderate deterioration and invasive plant growth. The roof membrane itself is significantly compromised.

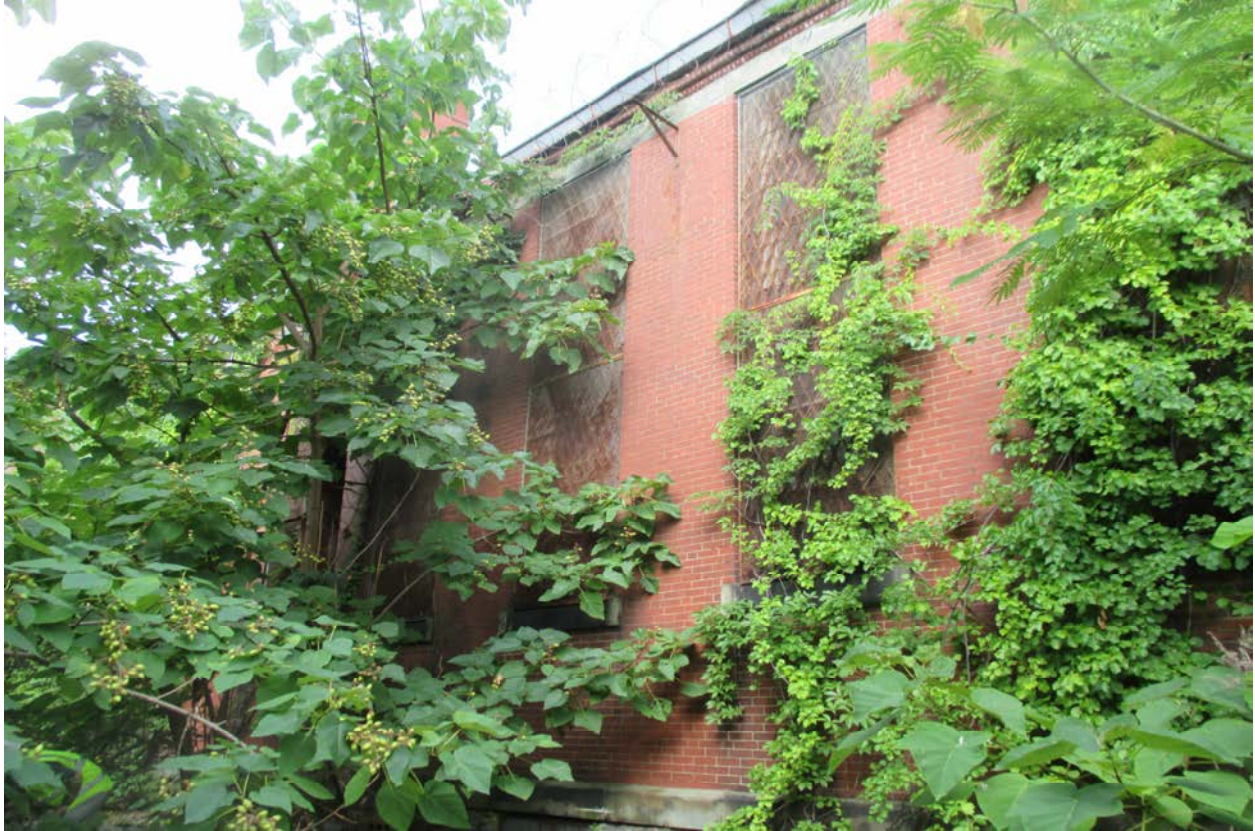
Figure 16. Vegetation at Phase III exterior, east prison yard

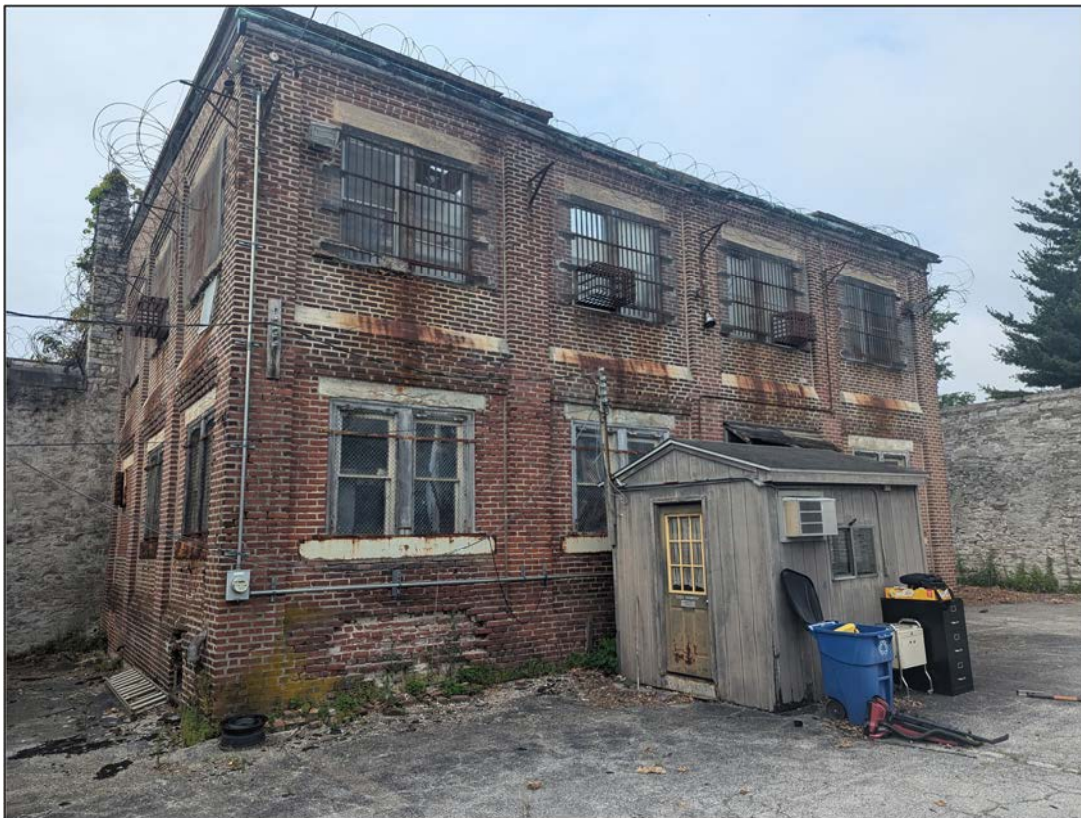
The roof and associated structure on Phase IV had collapsed before the 2020 Gannett Fleming report. Decay has progressed in the intervening years, and the area is unsafe. The open roof is also a major conduit for water entry into the other phases of the building, accelerating the decay of the other Phases. As the most recently completed prison portion, it is the least historically significant. CED recommends demolishing this building as part of any future development.

Figure 20. Phase IV exterior

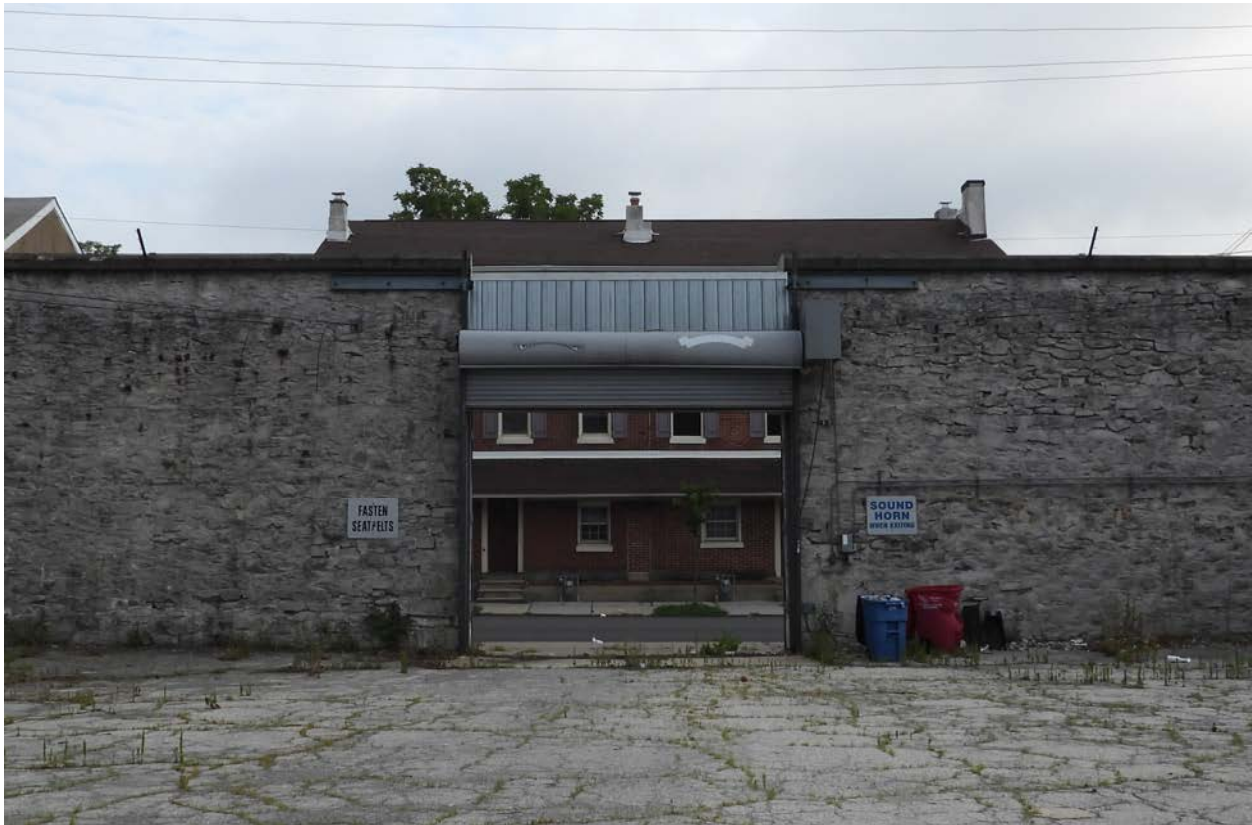
Currently, there is a rear roll-up gate at the rear of the prison yard, opening to Marshall Street. The dimensions of this opening are approximately 15’ high by approximately 18’ wide. The total dimensions should be confirmed. A geotechnical drilling rig was able to enter the site through this gate without any special consideration. Beyond the rear yard, the two side yards of the prison are blocked by arched openings. The openings will likely present access challenges for large construction equipment.

Figure 21. Marshall Street roll-up gate
