Report of Preliminary Geotechnical Exploration and Feasibility Study

Airy Street Prison Site Redevelopment

35 East Airy Street

Norristown, Montgomery County, Pennsylvania

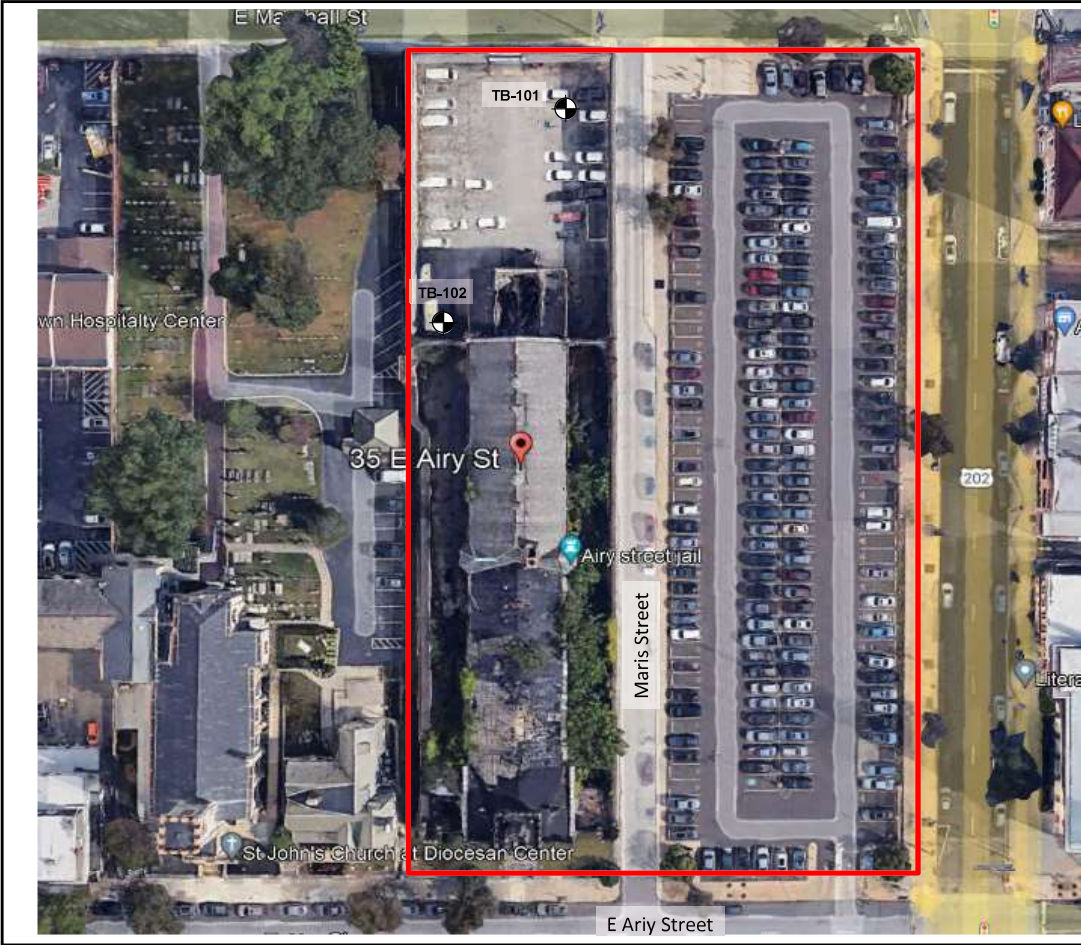
TITLE: EXPLORATION
LOCATION PLAN

TB-101 TEST BORING LOCATIONS
(APPROXIMATE)

[Red Outline] APPROXIMATE LIMITS OF PROPOSED
DEVELOPMENT

Subsurface conditions for this preliminary geotechnical exploration were explored through the completion of two test borings, identified as TB-101 and TB-102. The test borings were performed by Soil Borings Inc. of Haddonfield, New Jersey, at the locations shown on the Exploration Location Plan, Figure 2. CED performed component infiltration testing (IT-101 and IT-102) at offset locations adjacent to the test borings.

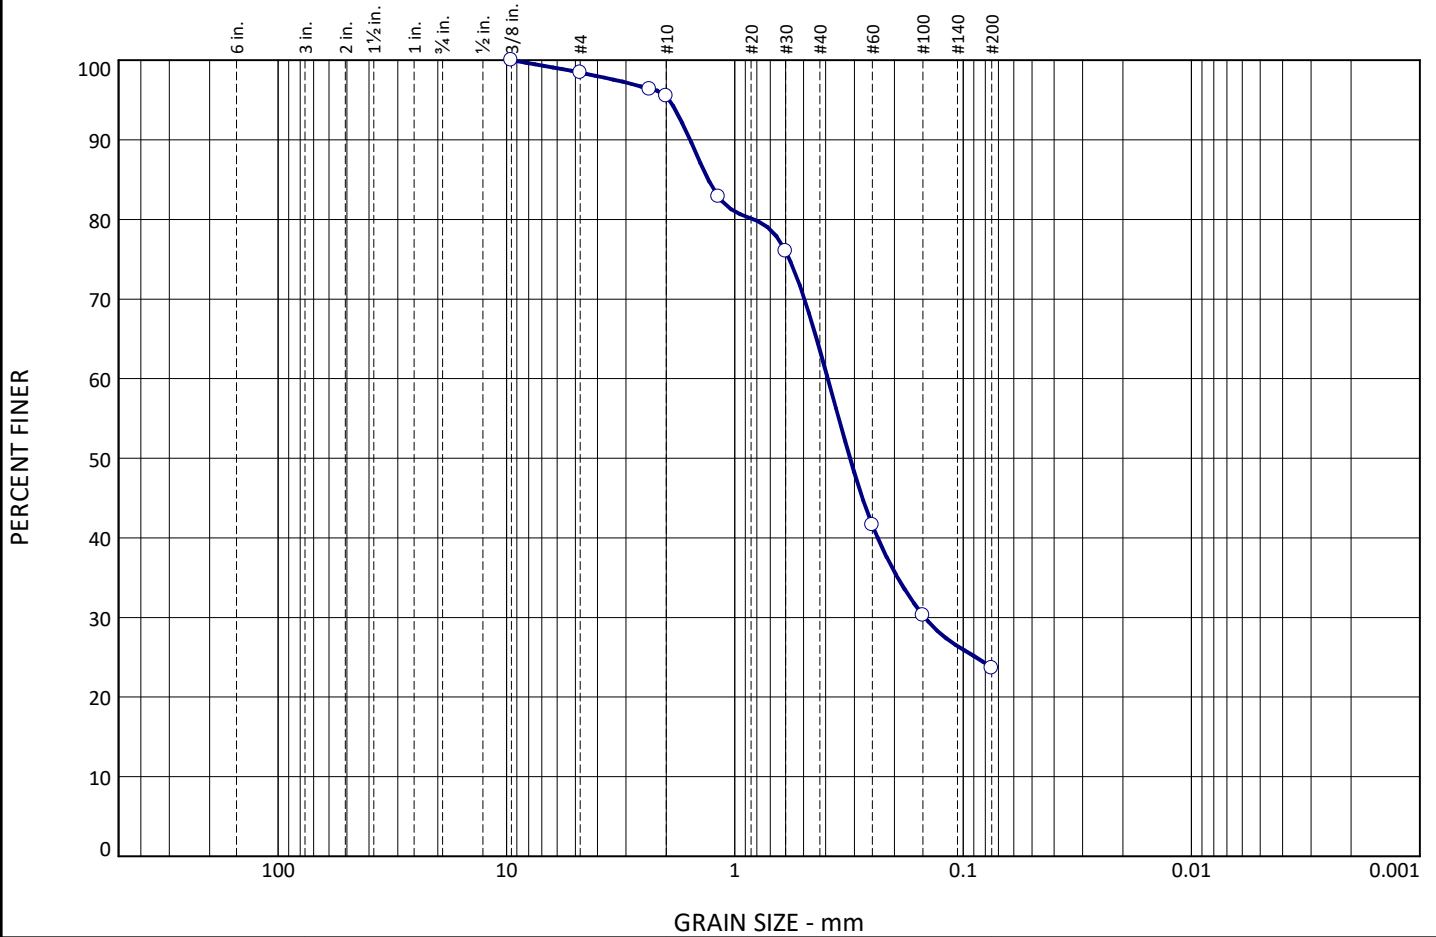
Source of Sample: TB-102 Depth: 0.5'-2' Date: 8/8/24
 Sample Number: S-1
